Structural and Rehabilitation Assessment of
Twenty-One Vacant Structures
On Behalf of the
City of Newburgh
Orange County, New York

July 24, 2015

Chazen Project No. 31561.00

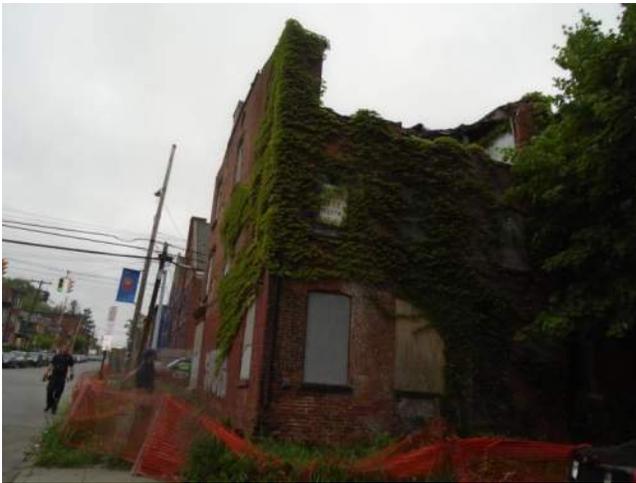
Front Elevation of subject structure. Access to the adjacent sidewalk has been restricted by a plastic fence. There is an adjacent three-story residential structure to the north of the subject structure.

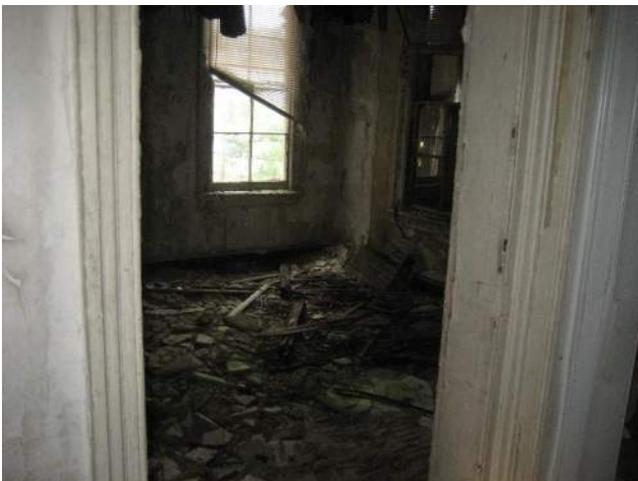
Photograph (5):
Representative view of the first floor of the subject structure. The interior is water damaged and organic-appearing growth is visible throughout the structure.

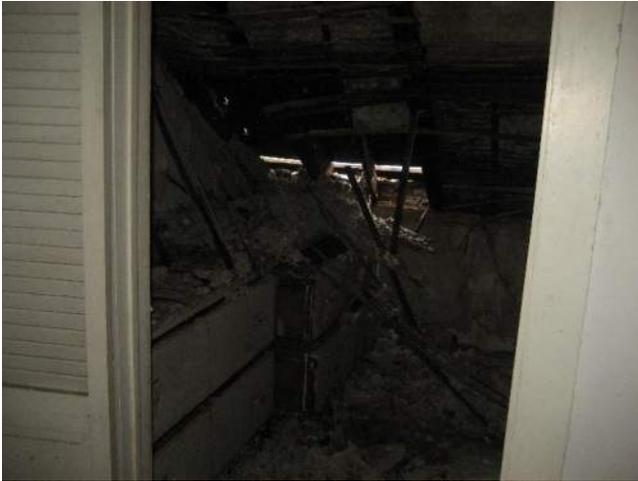
Photograph (6):
Representative view of the second floor of the subject structure below the active roof leaks. The load carrying capacity of this area is significantly reduced and is not safe to walk on.

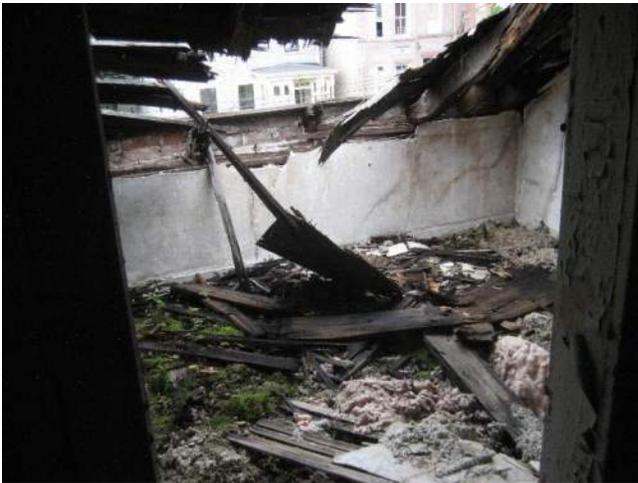
Photograph (7):

Representative view of the third floor of the subject structure below the active roof leaks. The load carrying capacity of this area is significantly reduced and is not safe to walk on. White colored insulation material is visible throughout this area.

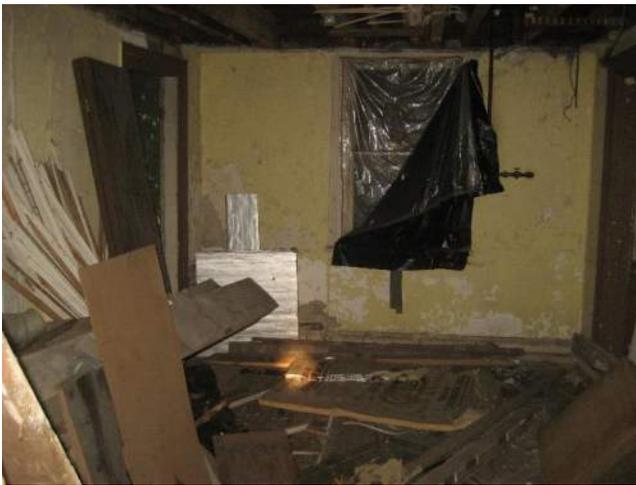
Representative view of the basement of the subject structure below the active roof leaks. The ceiling and floor structures in this area are severely deteriorated.

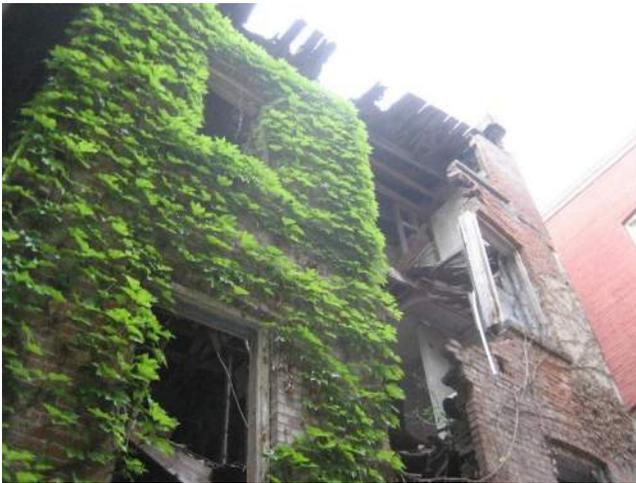
Photograph (1):

Front Elevation of the subject structure. The front façade is covered in climbing plants and its condition could not be directly observed. There are several windows that are not boarded in accordance with the municipal code. There is a pile of soil in front of the building and its purpose is unknown.

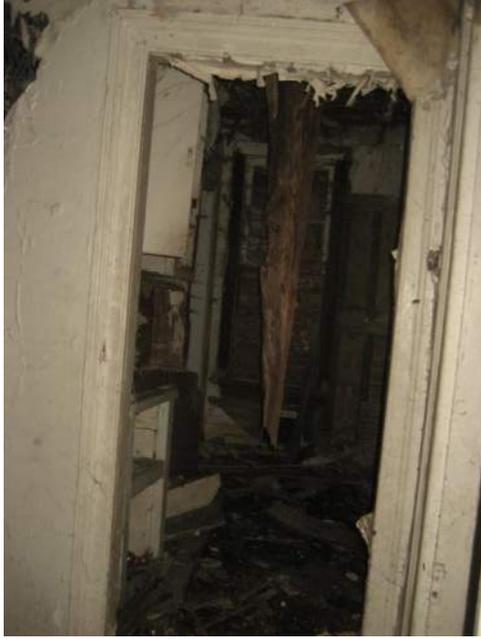
Photograph (3):

View of the interior staircase as viewed from the front entrance. The stairs are severely water damaged and unsafe.

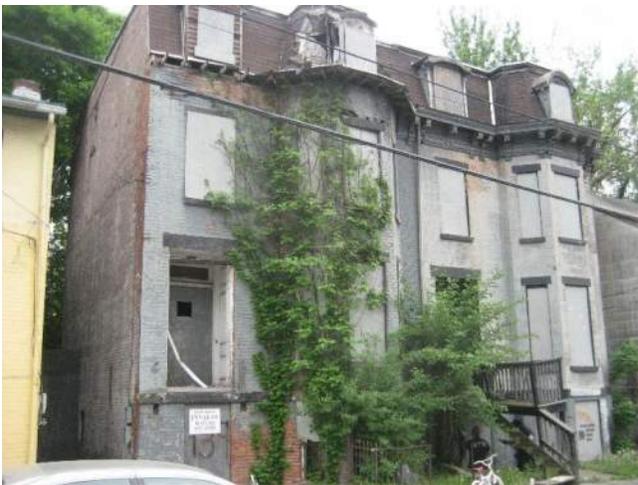
Photograph (1):

Front Elevation of the subject structure. 139 Lander is on the left and 137 Lander is on the right. The windows and doors are generally boarded but no ventilation screens are installed.

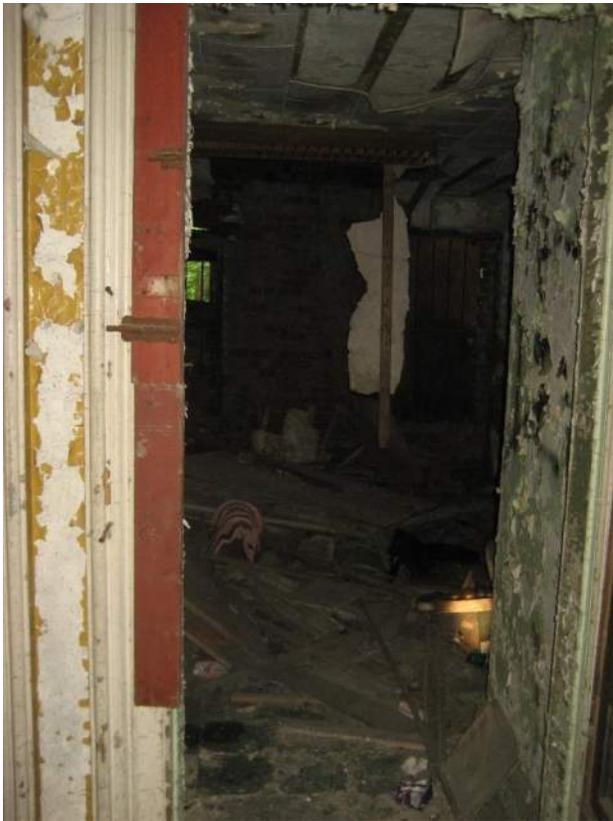
Interior view of the basement level of 139 Lander. The floor structures are severely water damaged and deteriorated.

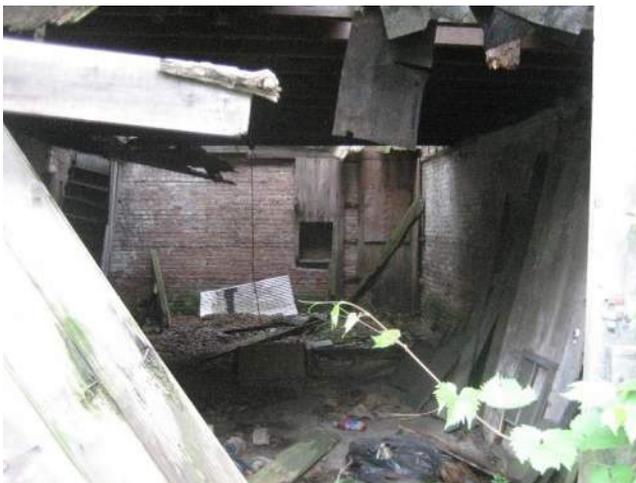
Exterior view of the carriage house in the rear of the subject structure. The roof structure is severely deteriorated and partially collapsed. The masonry walls are generally unstable and pose a fall hazard to the adjacent property. The exterior wall above the entrance is collapsing and is no longer fully supported by the door lintel. The exterior masonry walls are covered in climbing plants and all areas could not be directly observed.

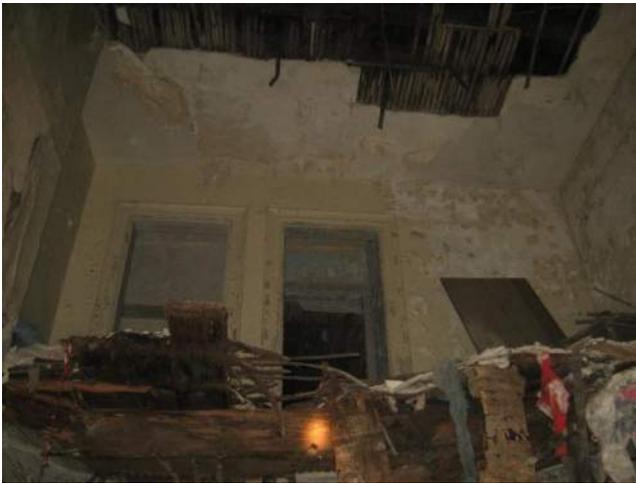
Representative view of the first floor interior as viewed from the rear entrance. The floor structure has collapsed into the basement level. There are piles of combustible debris and the interior is severely water damaged.

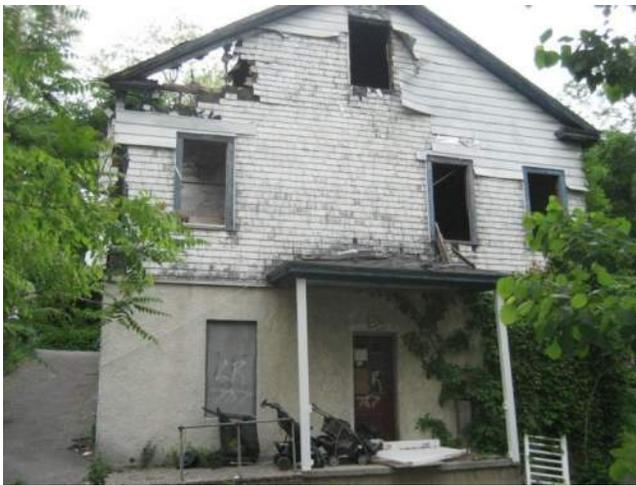
Front Elevation of the subject structure. Extensive fire damage is visible and the roof has partially collapsed.

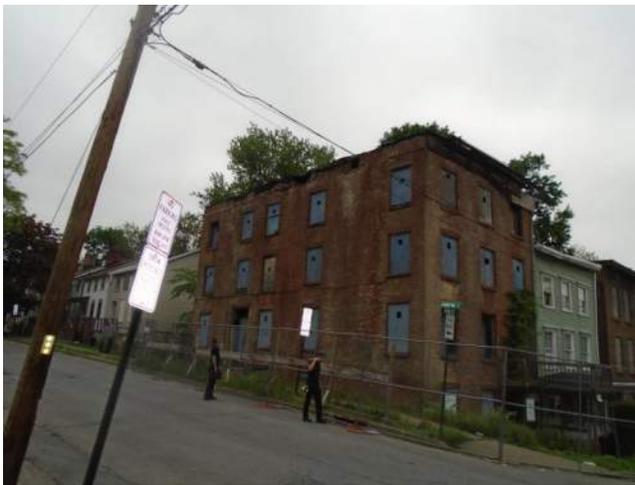
Front Elevation of the subject structure. The wood cornice structure at the roof level is unsecured and poses a fall hazard.

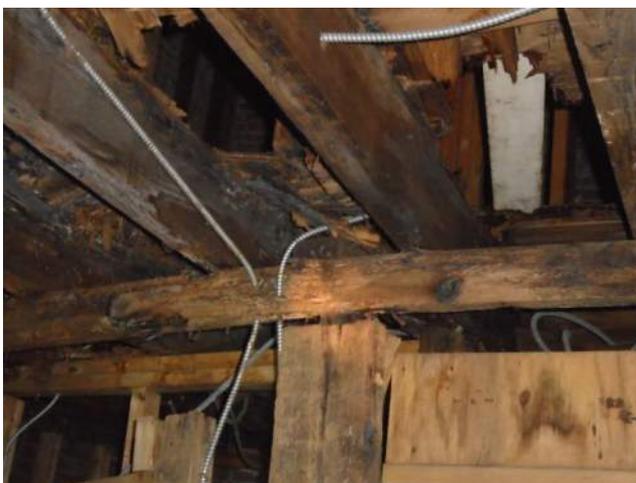
Photograph (5):

Representative interior view of the first floor of the subject structure. The wood structures are severely deteriorated and are in a state of collapse.

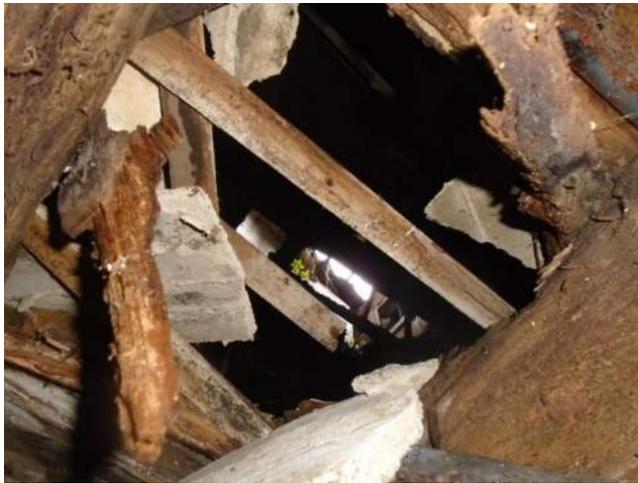
Representative interior view of the subject structure. The interior is severely water damaged.

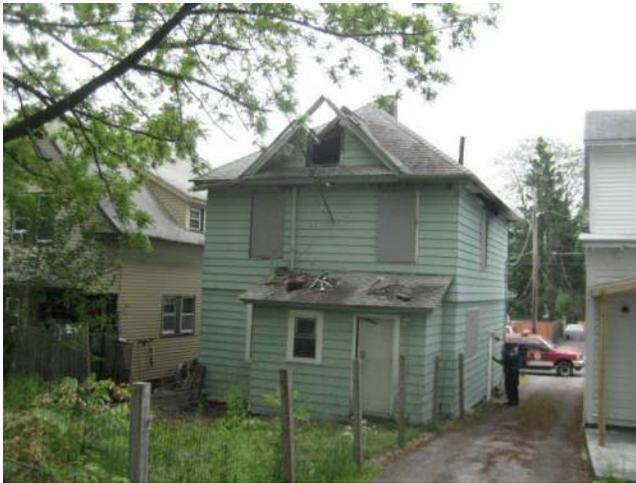
Front Elevation of the subject structure. Fire damage is visible in the attic dormer. Access to the interior is provided on the door from the driveway (left elevation).

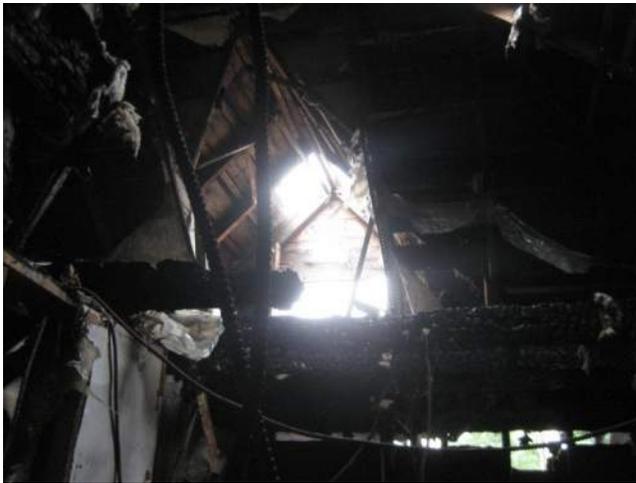
Interior of the subject structure as viewed from the second floor. Extensive fire damage is visible through the roof structure. Portions of the second floor structure have collapsed and pose a fall hazard to first responders.
