Structural and Rehabilitation Assessment of
Twenty-One Vacant Structures
On Behalf of the
City of Newburgh
Orange County, New York

July 24, 2015

Chazen Project No. 31561.00

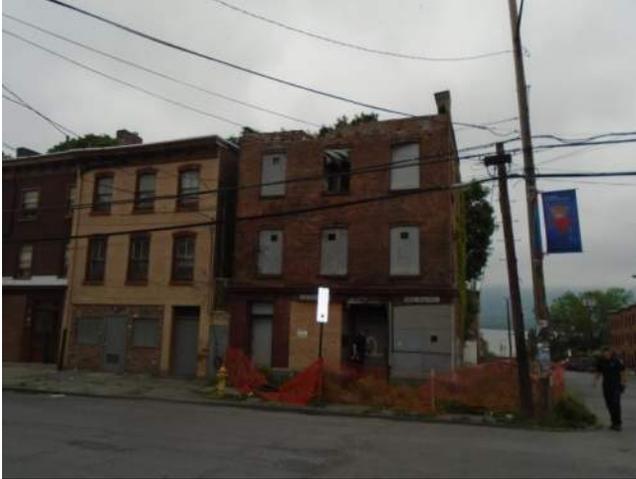
Photograph (1):

Front Elevation of subject structure. Access to the adjacent sidewalk has been restricted by a plastic fence. There is an adjacent three-story residential structure to the north of the subject structure.

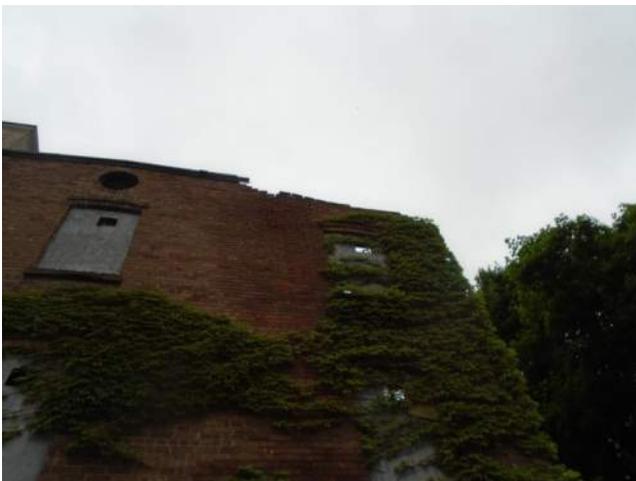
Photograph (3):

Right Elevation of subject structure. The roof structure has collapsed. The exterior wall along Renwick Street is no longer braced by roof structure and poses a fall hazard.

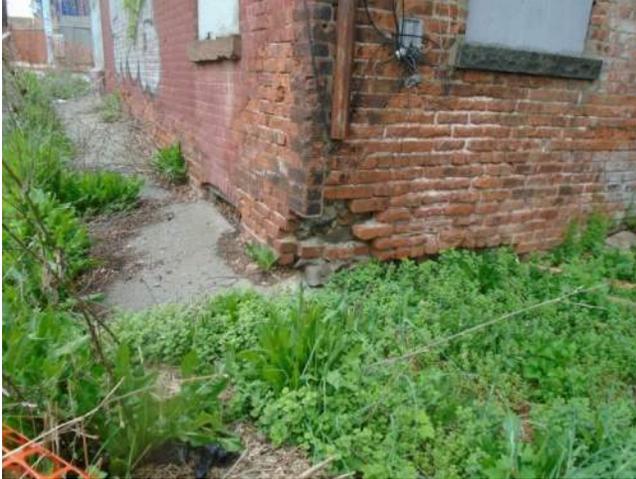
Photograph (4):

Exterior corner of subject structure. The downspout has been damaged and the resulting discharge has deteriorated the corner of the building. The top of windows are visible at ground level.

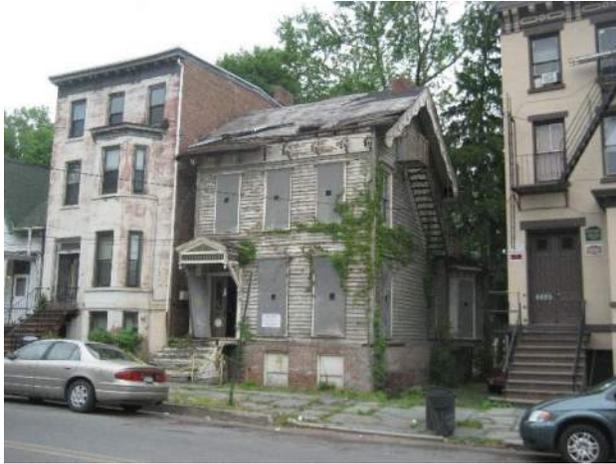
Photograph (1):

Front Elevation of the subject structure. The roof has locally collapsed in the front of the structure. Portions of the roof and cornice structures are unsecure and pose a fall hazard.

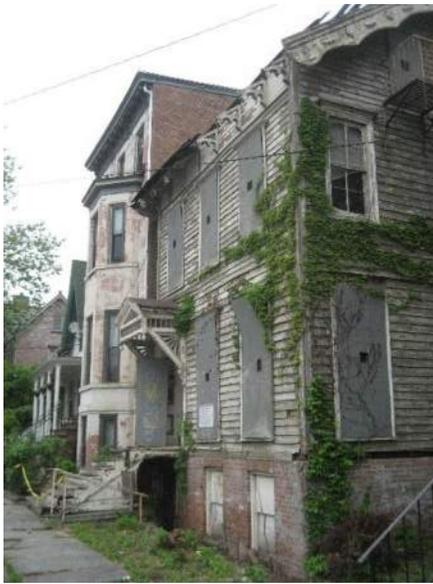
Photograph (2):

Front Elevation of the subject structure. The front steps are in poor condition and pose a fall hazard.

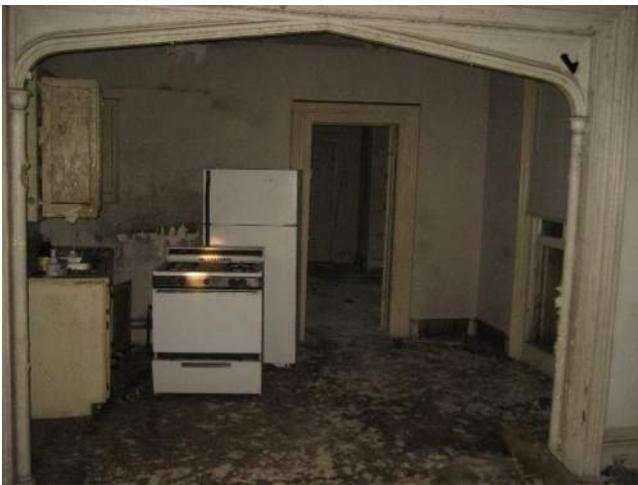
Photograph (5):
Representative view of the first floor of the subject structure. The interior is water damaged and organic-appearing growth is visible throughout the structure.

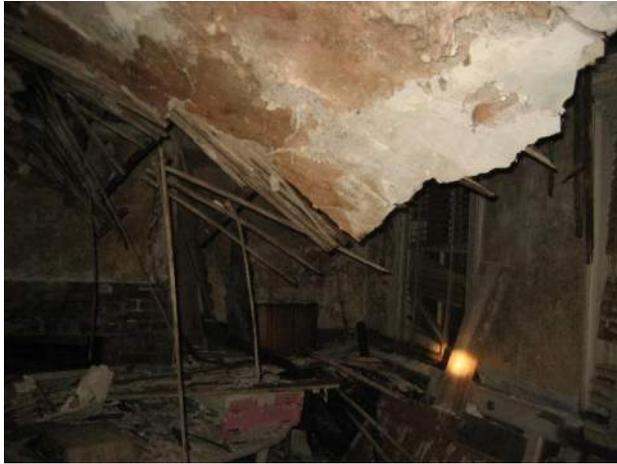
Photograph (10):

Representative view of the basement of the subject structure below the active roof leaks. The ceiling and floor structures in this area are severely deteriorated.

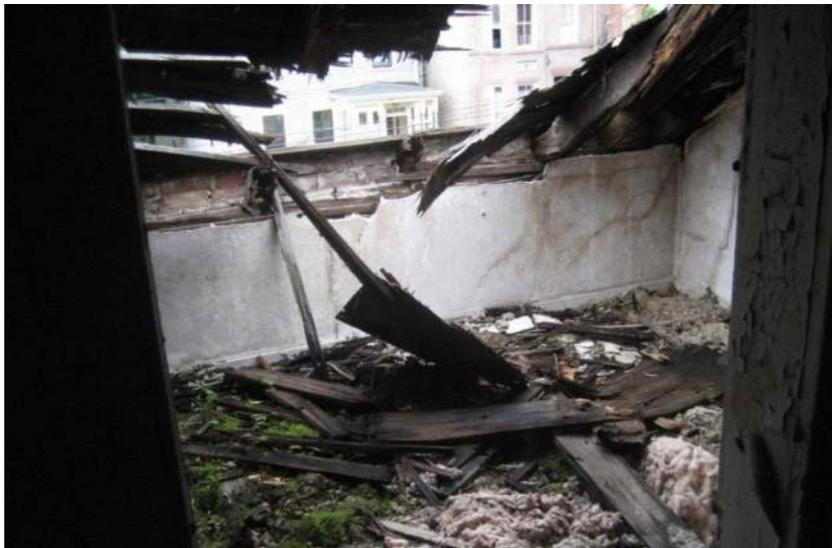
Roof Condition at
Front of Attic

Weather-tight? No. Front roofing is missing; roof deck exposed and missing; water entering front rooms.
Secured? Partially. Most windows covered w/plywood, w/vents on upper floors. Open roof = critter entry.

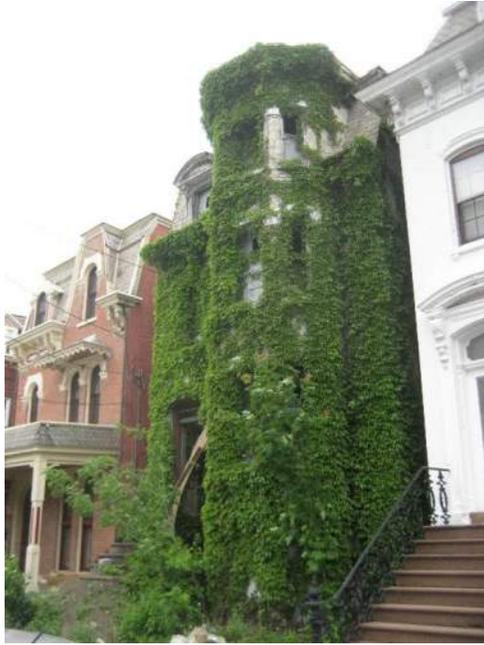
Photograph (1):

Front Elevation of the subject structure. The front façade is covered in climbing plants and its condition could not be directly observed. There are several windows that are not boarded in accordance with the municipal code. There is a pile of soil in front of the building and its purpose is unknown.

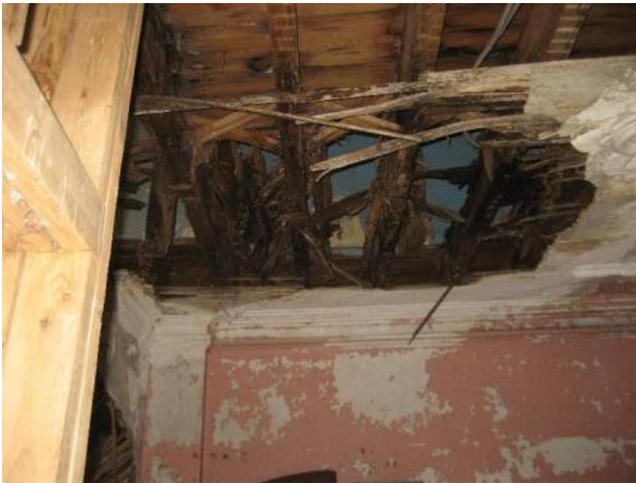
Photograph (5):

Interior view of water damaged and deteriorating floor boards in the rear of the subject structure. Newer appearing framing is visible near this area and may be an attempt to shore this condition.

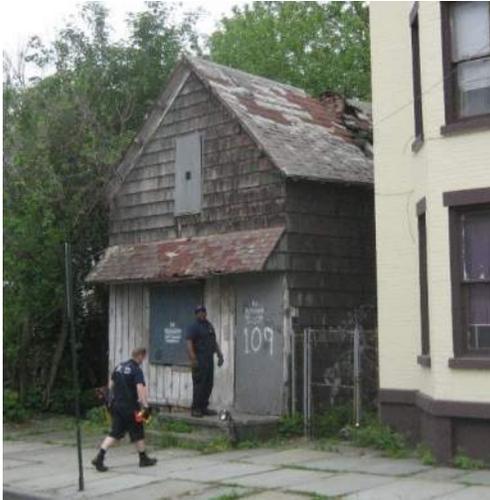
Photograph (1):

Front Elevation of the subject structure. The center of the roof structure has collapsed.

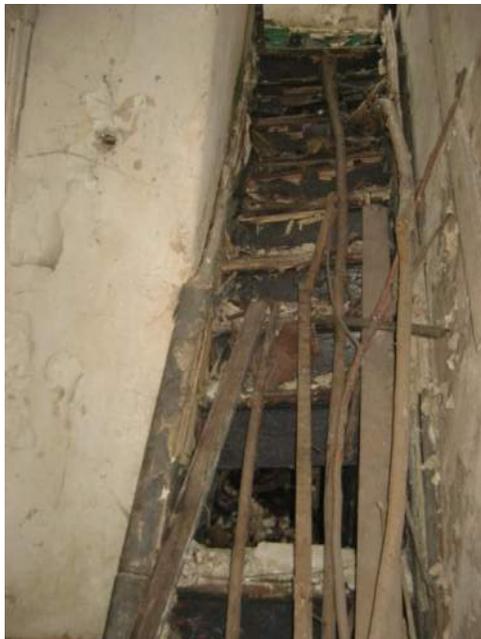
Photograph (3):

View of the interior staircase as viewed from the front entrance. The stairs are severely water damaged and unsafe.

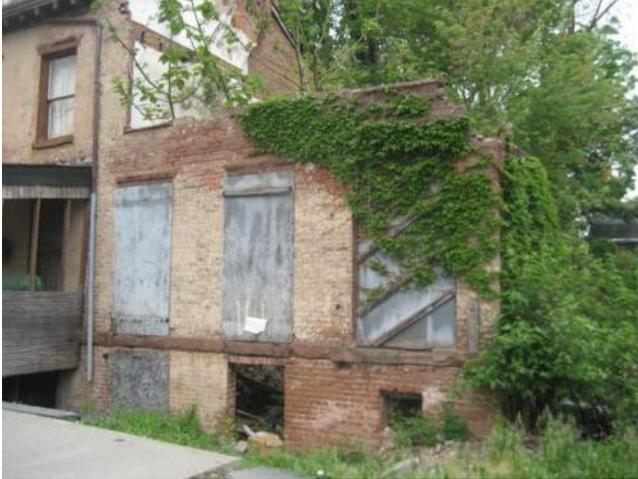
Photograph (1):

Front Elevation of the subject structure. The interior of the structure has completely collapsed.

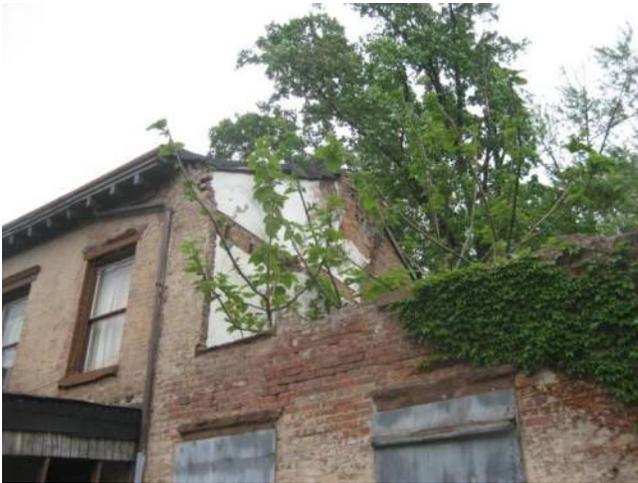
Photograph (2):

Front Elevation of the subject structure. The subject structure is a row house that is structurally connected to 163 Lander Street. The subject structure appears to have been a two story structure, but the top half has been removed / collapsed inwards.

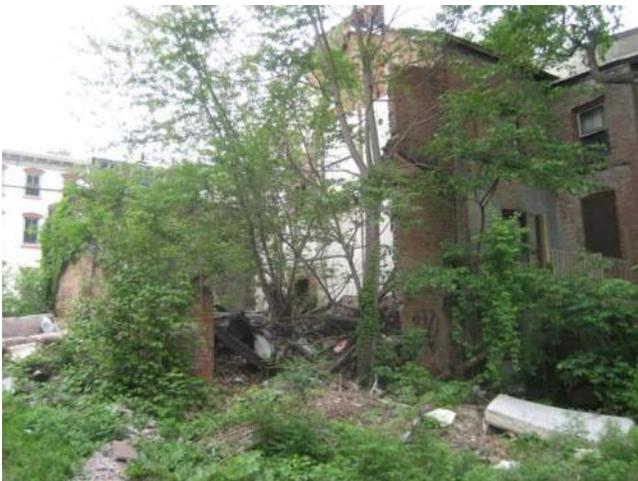
Photograph (3):

Rear Elevation of the subject structure. The subject structure is a row house that is structurally connected to 163 Lander Street. There is a tree growing in the rubble pile, imply the property has been vacant for several years. The remnants of the exterior brick walls are unbraced and unstable.

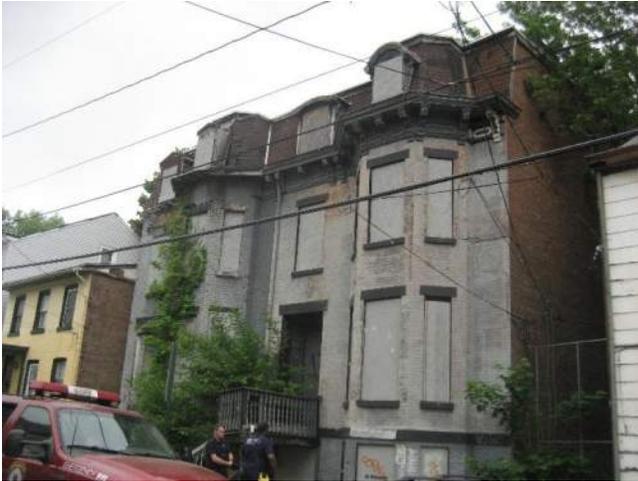
Photograph (1):

Front Elevation of the subject structure. 139 Lander is on the left and 137 Lander is on the right. The windows and doors are generally boarded but no ventilation screens are installed.

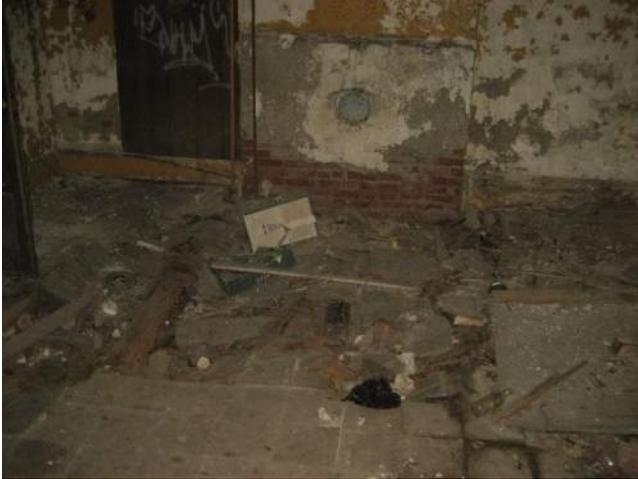
Photograph (4):

Interior view of the basement level of 139 Lander. The floor structures are severely water damaged and deteriorated.

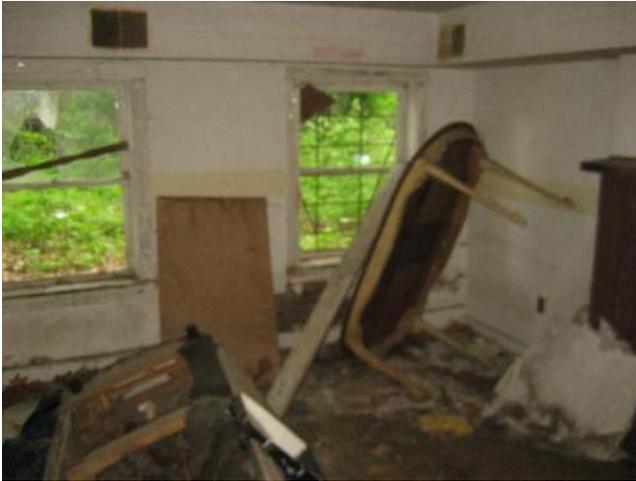
Photograph (6):

Interior view of the basement level of 137 Lander. The rear windows are not secured they are open to the weather, pests and trespassers.

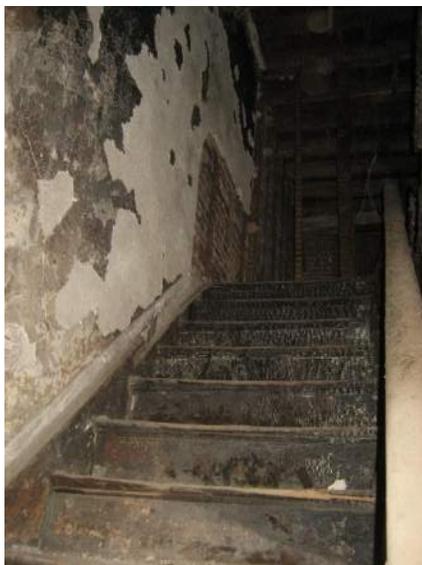
Photograph (8):

Interior view of the staircase that leads to the second level of 137 Lander. The staircase is fire damaged and its load carrying capacity is unknown. Chazen did not try and access the upper levels via this staircase.

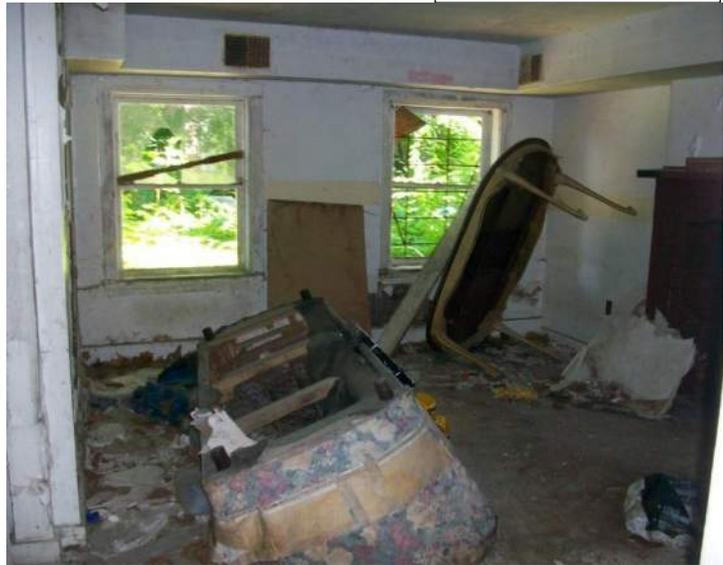
Interior –
Typical Conditions
Localized water damage

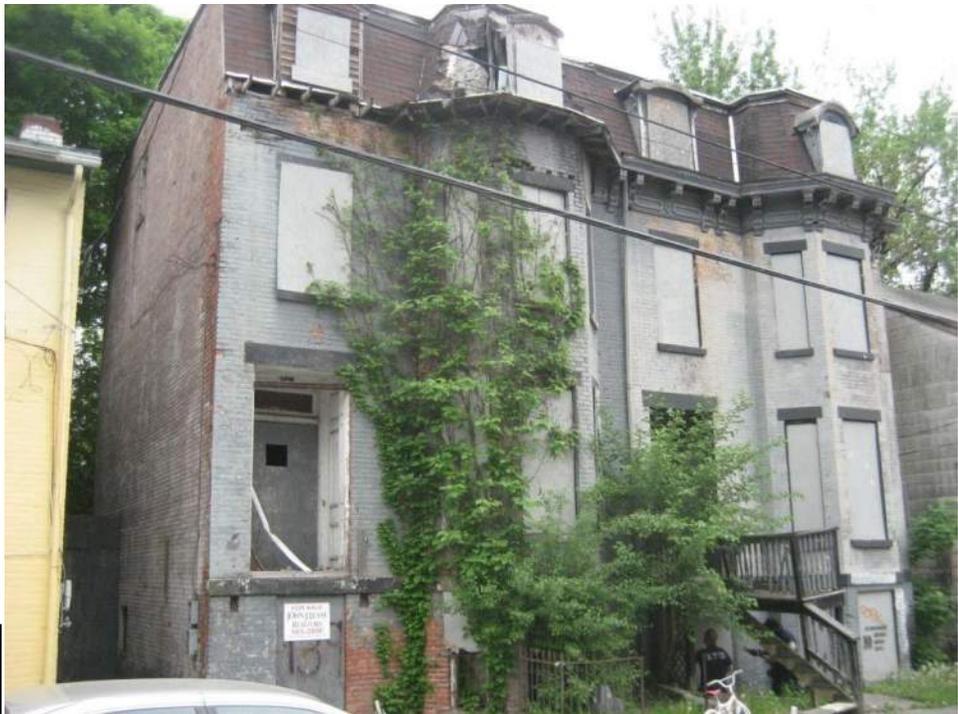
Front View:
139 (left) + 137 (right)

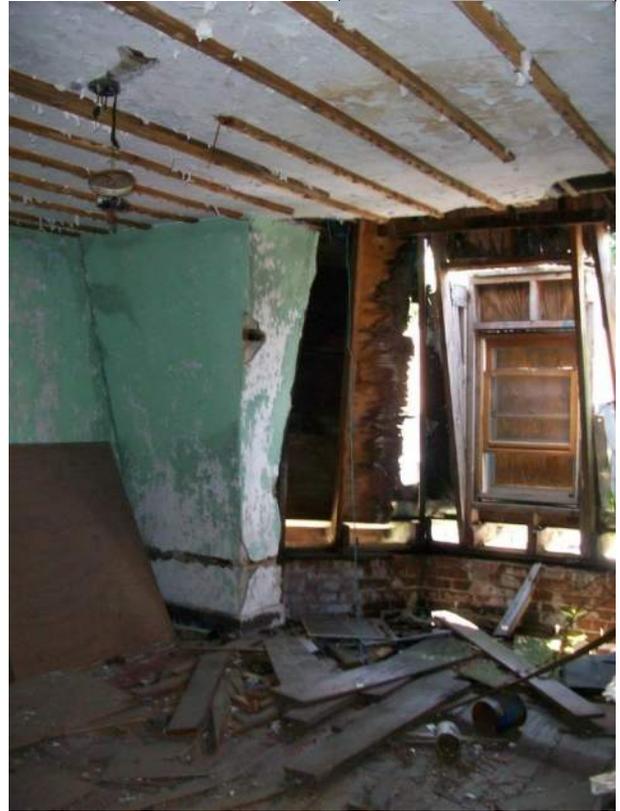
Interior – 1st Floor
Typical Conditions

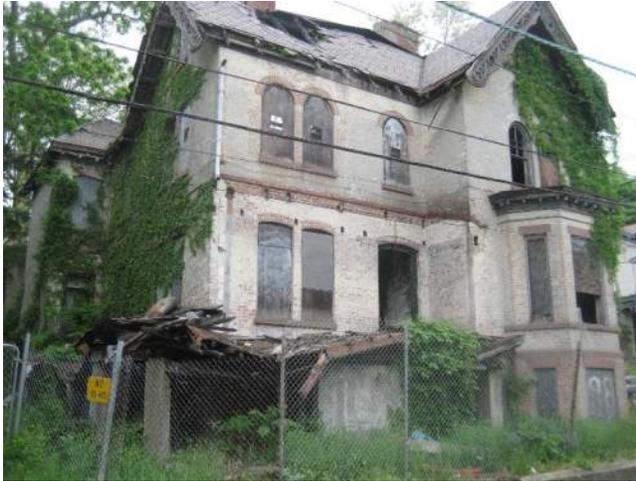
Photograph (1):

Front Elevation of the subject structure. The wooden roof and porch structures are severely deteriorated and partially collapsed. Several of windows are no longer boarded. There is a chain link fence around the property to limit access. The yard is overgrown and full of debris.

- The City should repair the leaning perimeter chain link fence to help limit access to the site.

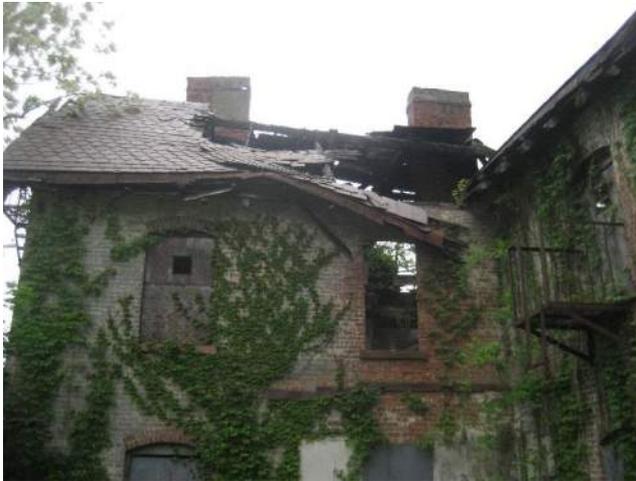
Photograph (2):

Rear Elevation of the subject structure. The wooden roof structure is partially collapsed. Several of windows are no longer boarded. The collapsing roof structure no longer fully braces the exterior masonry walls and chimney structures.

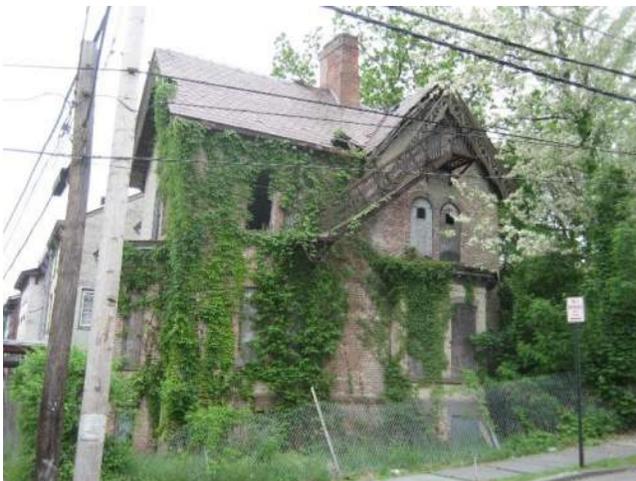
Photograph (3):

Right Elevation of the subject structure. The wooden roof structure is partially collapsed. Several of windows are no longer boarded. There are climbing plants growing on the exterior walls. The chain link fence is tilting on this side of the property.

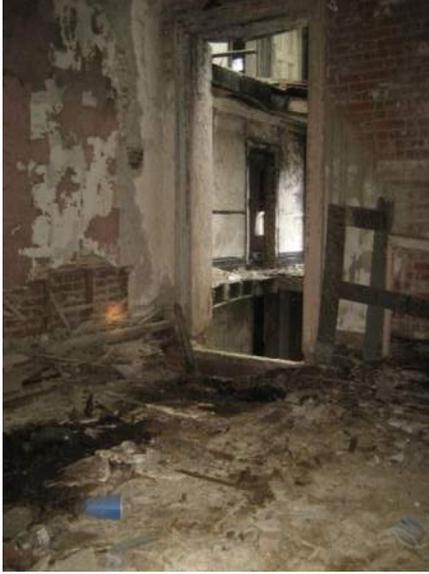
Photograph (4):

Representative view of the interior of the subject structure, as viewed from the rear entrance. The center roof and floor structures have collapsed and are open to weather. The interior is severely water damaged.

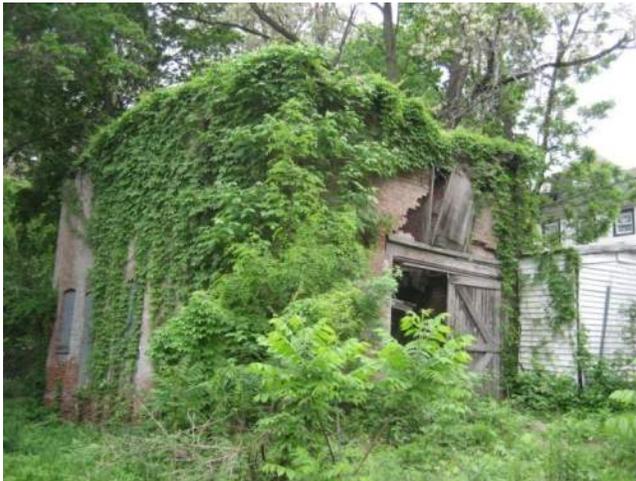
Photograph (5):

Exterior view of the carriage house in the rear of the subject structure. The roof structure is severely deteriorated and partially collapsed. The masonry walls are generally unstable and pose a fall hazard to the adjacent property. The exterior wall above the entrance is collapsing and is no longer fully supported by the door lintel. The exterior masonry walls are covered in climbing plants and all areas could not be directly observed.

- Special care should be taken to safeguard the existing adjacent shed structure adjacent to the carriage house. While the two structures do not appear attached, they are close to each other (within four feet). Demolition will need to be performed in a controlled manner. The owner of this adjacent property should be immediately notified of the unsafe condition of the subject structure and carriage house. Adjacent structures shall need to be protected against dust and other hazards during demolition. Refer to the “demolition” section of this report for additional recommendations.

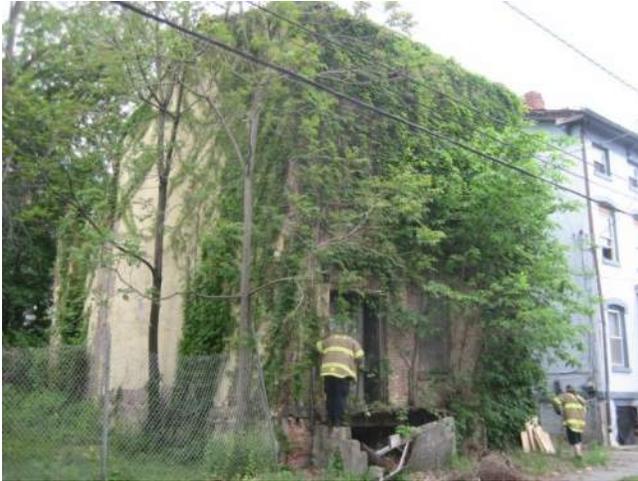
Photograph (1):

Front Elevation of the subject structure. The front porch has collapsed and access to the interior is difficult. There are climbing plants that cover the front and side elevations.

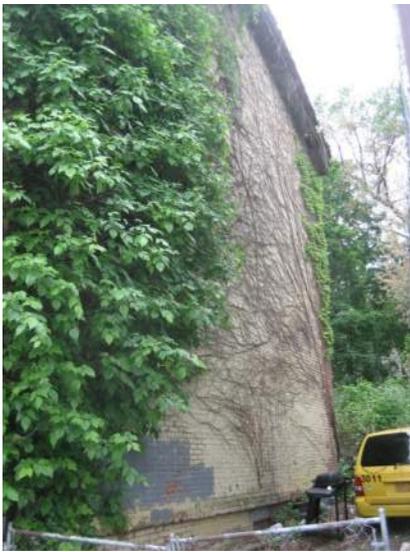
Photograph (2):

Right Elevation of the subject structure. The driveway to the adjacent property is located near the subject structure. The top of a ground-level window is visible which likely leads to a basement level.

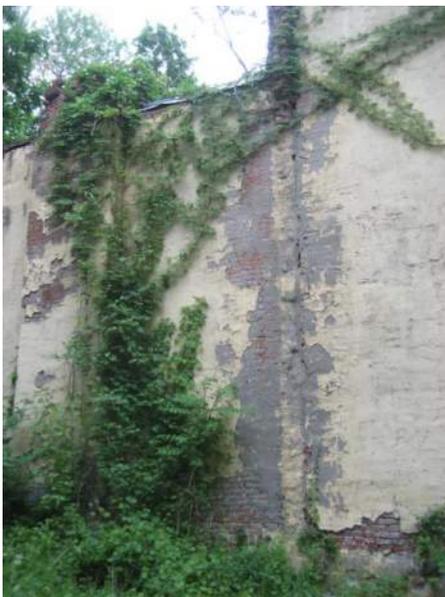
Photograph (3):

Left Elevation of the subject structure. There is a vacant lot adjacent to the subject structure. The exterior masonry wall is deteriorating and the cementitious covering is spalling. The top of the masonry chimney appears to be collapsing into the building. The rear portion of the subject structure appears to be one-story shorter than the front. The joint in the exterior masonry wall at the roof step is cracking and opening.

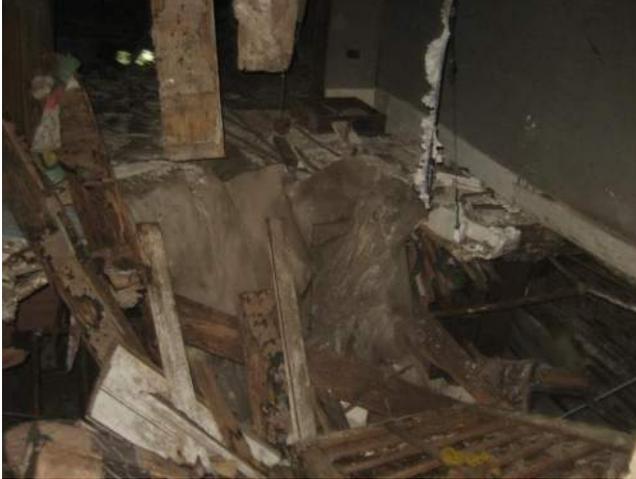
Photograph (4):

Representative view of the first floor interior as viewed from the rear entrance. The floor structure has collapsed into the basement level. There are piles of combustible debris and the interior is severely water damaged.

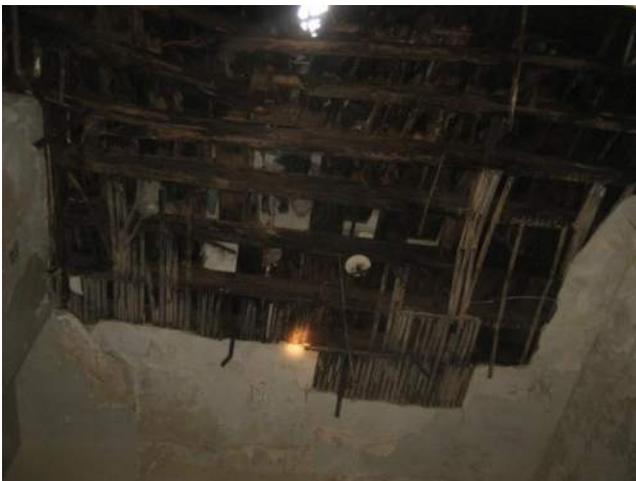
Photograph (6):

Representative view of the roof interior as viewed from the rear entrance. The roof structure is collapsing into the basement level. Daylight is visible through the roof structure and this portion of the building is open to weather. There are piles of combustible debris and the interior is severely water damaged.

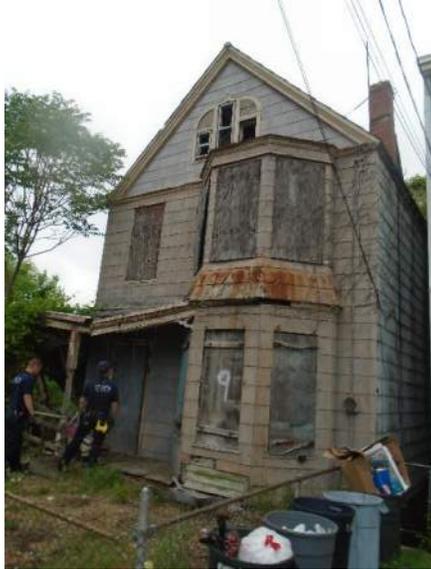
Photograph (1):

Front Elevation of the subject structure. The wooden front porch is in poor condition and is collapsing.

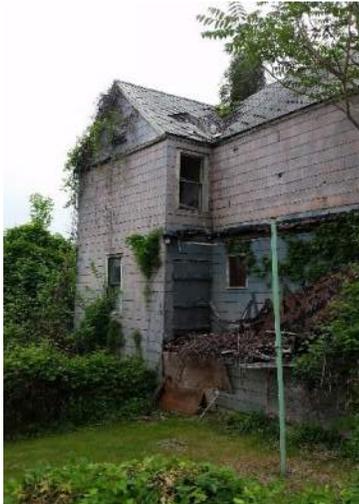
Photograph (2):

Left Elevation of the subject structure. The wooden side porch has collapsed. Several of the windows are not boarded. A local area of the roof has collapsed and is open to the weather.

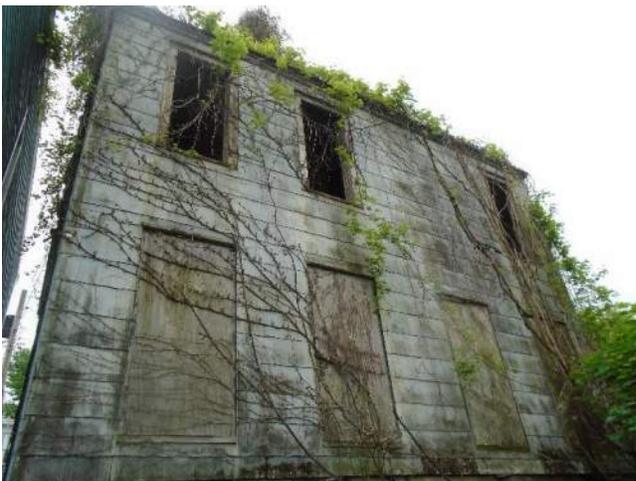
Photograph (3):

Rear Elevation of the subject structure. Several of the windows on the upper level are not boarded. Climbing plants are growing up the exterior and entering the interior. These plants appear to be crossing over to the adjacent structure.

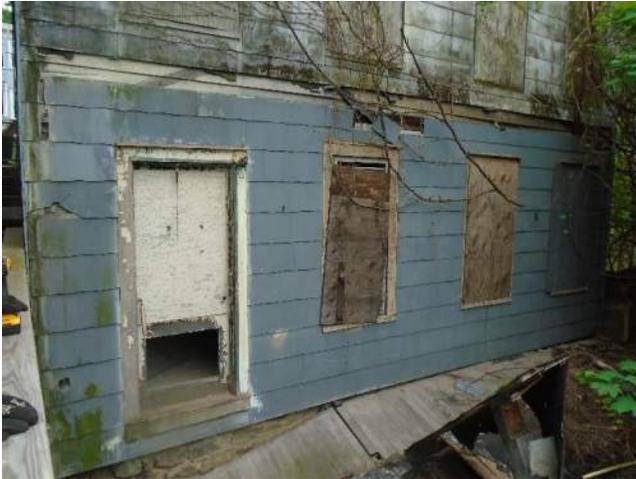
Photograph (4):

Rear Elevation of the subject structure. The rear porch has collapsed. The rear door is open to the exterior.

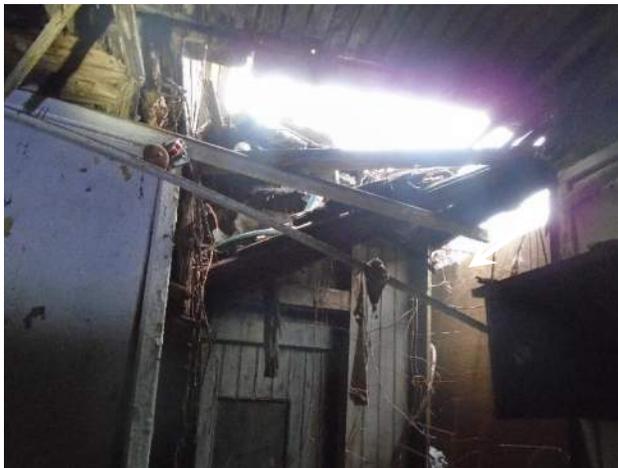
Photograph (6):

View of a collapsing portion of the roof structure.

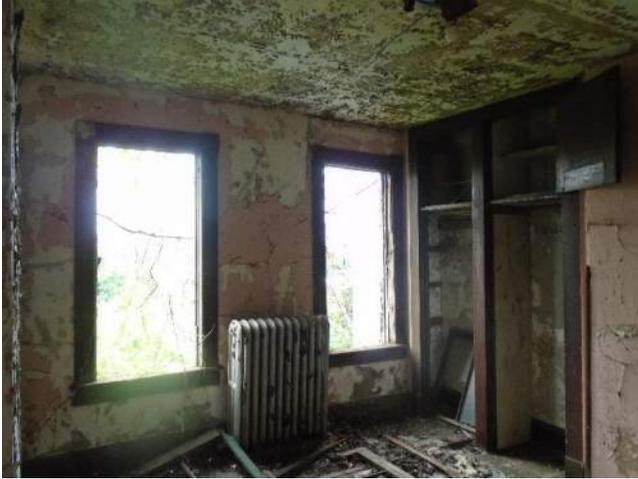
Photograph (7):

Representative interior view of the upper floor. The finishes are generally in fair to poor condition. There is peeling paint and dark colored organic appearing growth throughout the subject structure.

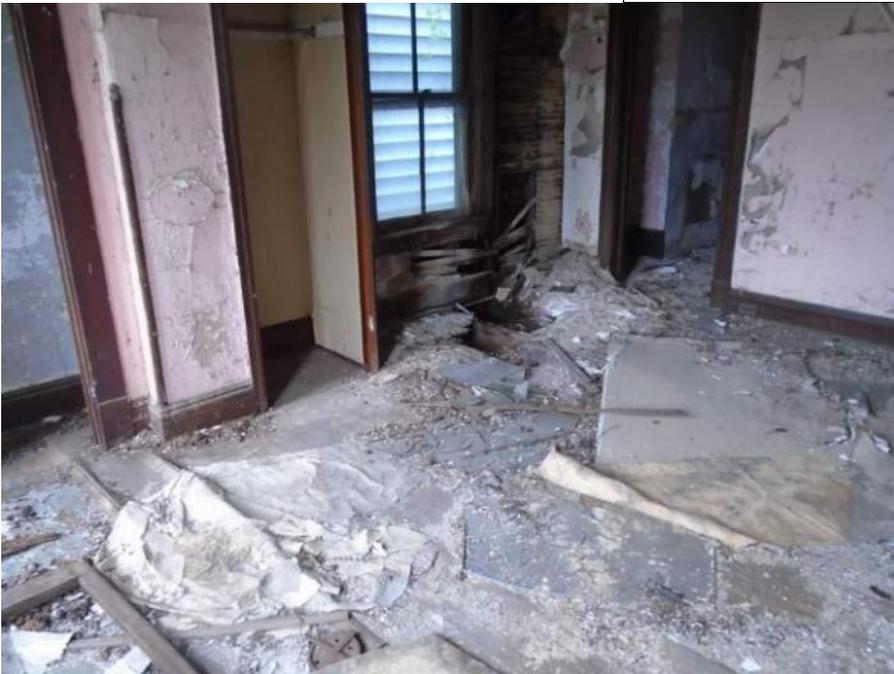
Interior --
Typical Conditions

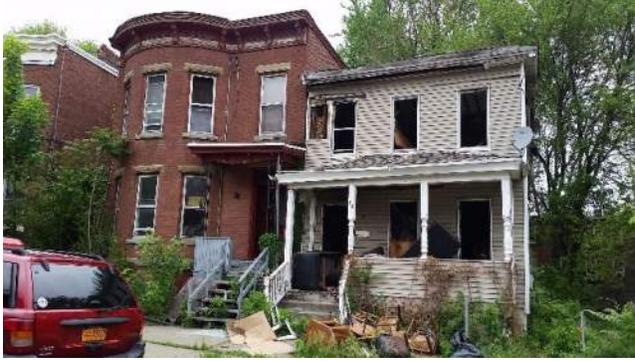
Photograph (1):

Front Elevation of the two story wood framed subject structure. The structure is built next to an adjacent brick residential structure. The windows and doors are not secured.

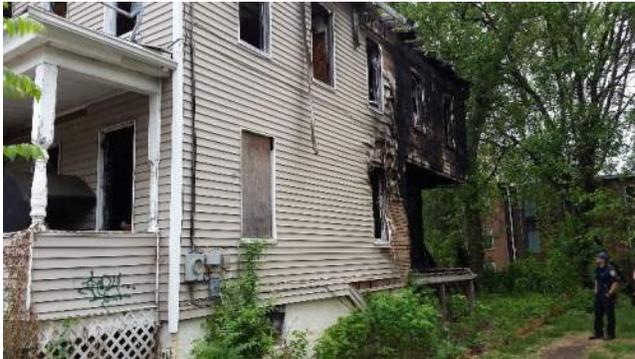
Photograph (2):

Right Elevation of the subject structure. The rear half of the structure is significantly fire and water damaged. The rear corner of the structure appears to cantilever over the porch.

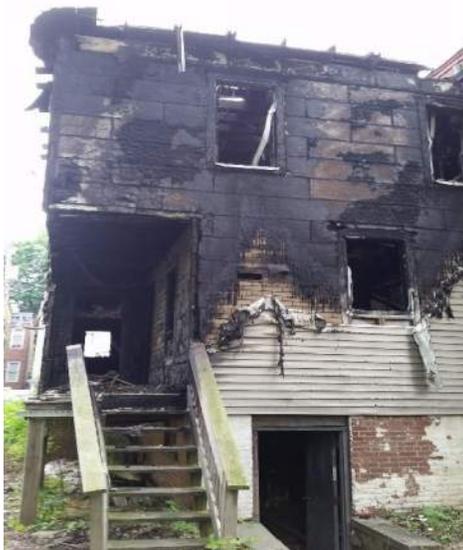
Photograph (3):

Rear Elevation of the subject structure. The rear half of the structure is significantly fire and water damaged. The rear corner of the structure appears to cantilever over the porch. The windows and doors are not secured.

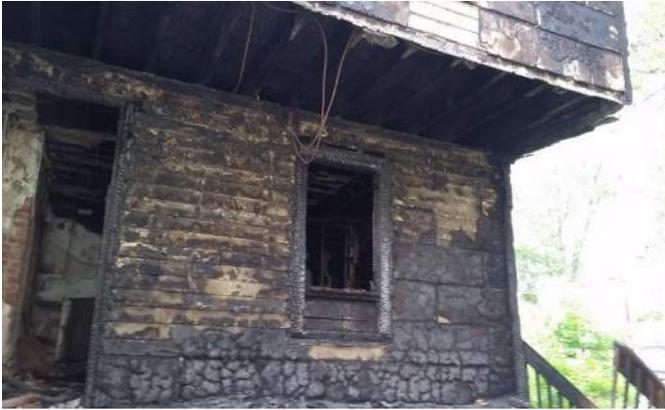
Photograph (4):

Rear Elevation of the subject structure. The rear half of the structure is significantly fire and water damaged. The rear corner of the structure appears to cantilever over the porch. The windows and doors are not secured.

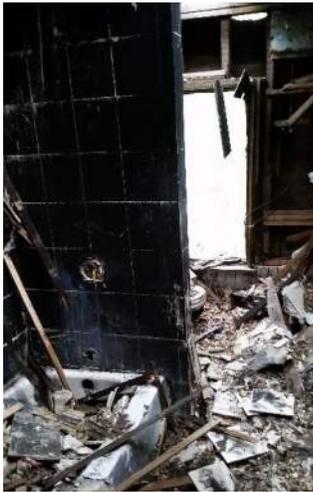
Photograph (5):

Representative interior view of the subject structure.

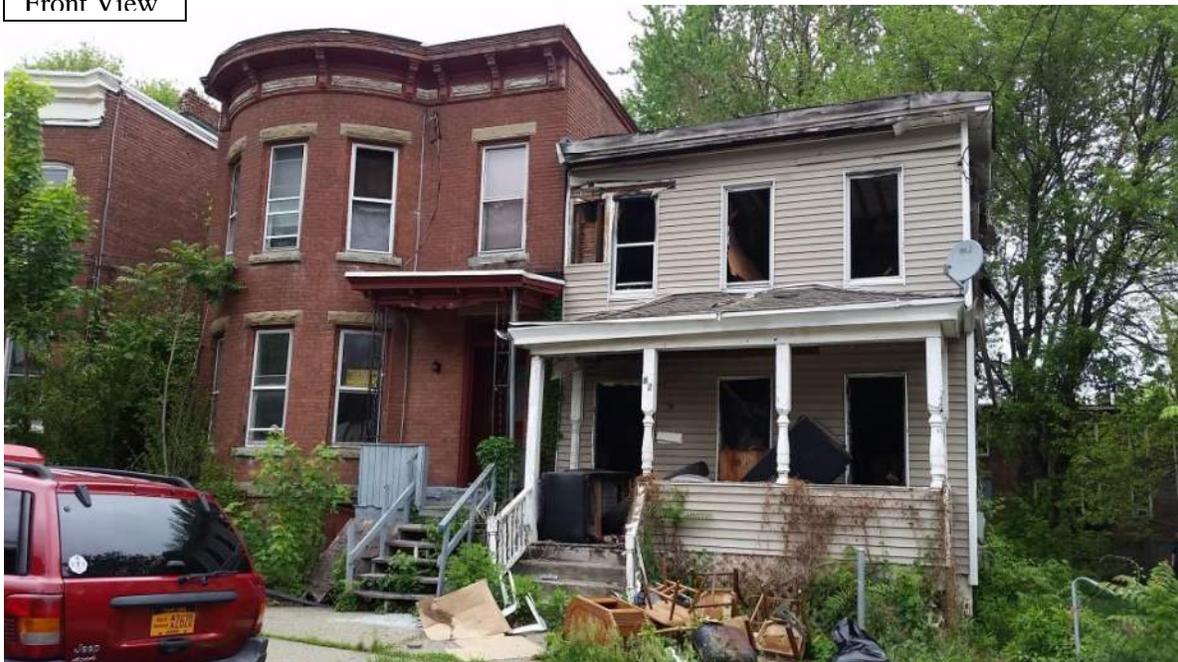
Front View

Front/South: Vinyl siding in fair-to-poor condition over asphalt brick siding over wood clapboard. Front porch structurally sound; finishes need repair/replacement.
R side/East: Vinyl siding in poor condition over asphalt brick siding over wood clapboard. Siding badly burned at rear corner. Remove and replace all. Rear porch columns and beam missing so that 2nd floor is cantilevered/unsupported over porch area.
Rear/North: Vinyl siding in poor condition over asphalt brick siding over wood clapboard. Siding badly burned at rear corner. Remove and replace all.
L side/West: Inaccessible; building is tight to adjacent house.
Foundation: Brick, in good condition.
Roof: Nearly flat, extremely low slope, pitching to both front and rear. Roofing material not visible/unknown. Several holes in roofing and deck. Eaves and rake damaged and missing either to water or fire damage. Re-framing, re-decking, and re-roofing required.

| <i>Type of Work</i> | <i>Estimated costs</i> | <i>Comments</i> |
|---|--|--|
| Mothballing* | \$23,000 - \$28,000 | Entire roof replacement; stabilizing rear structure by adding columns & beam at rear porch; boarding up windows; debris removal. |

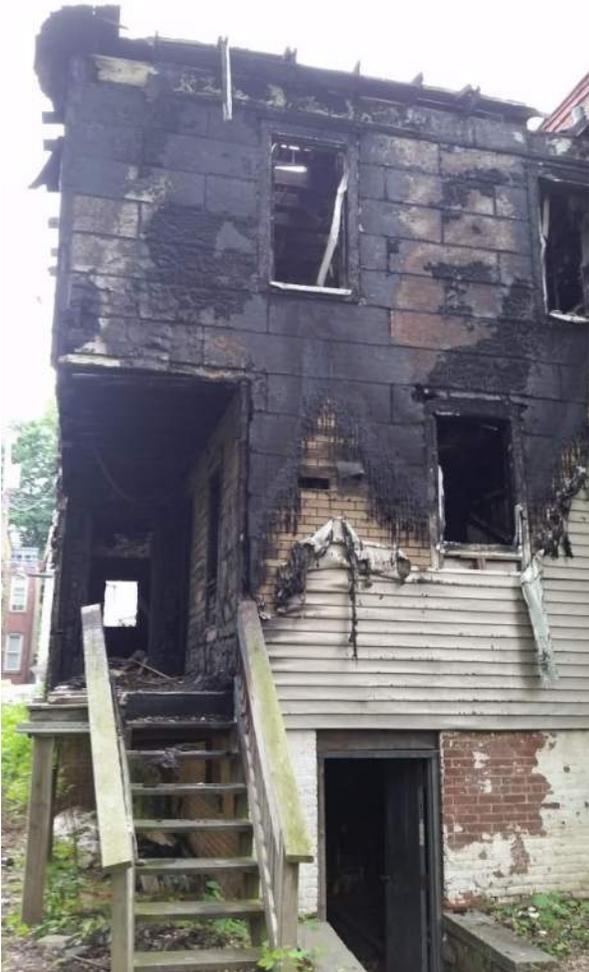
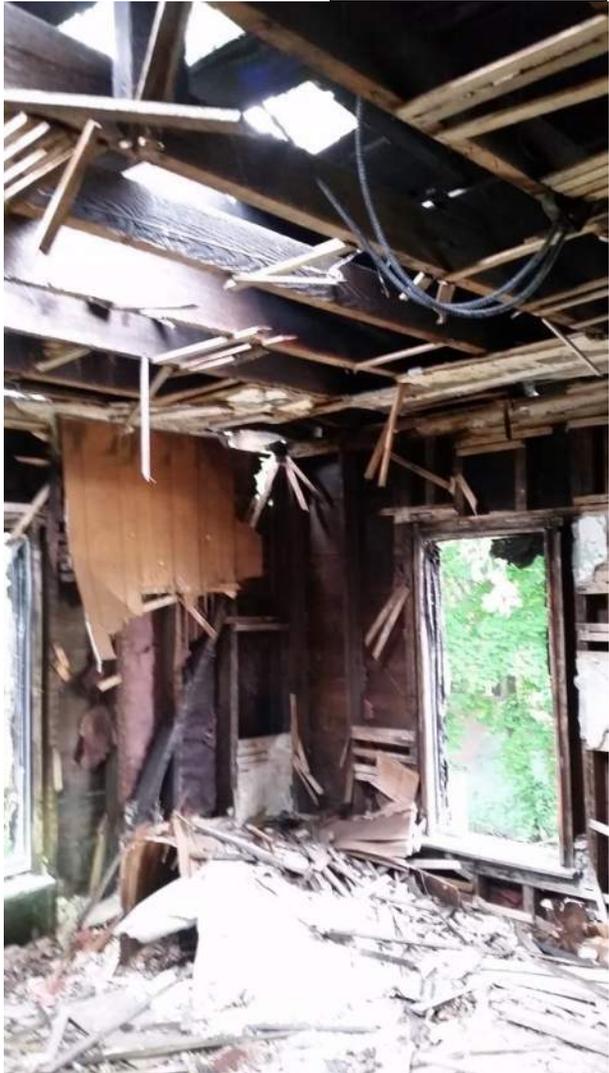
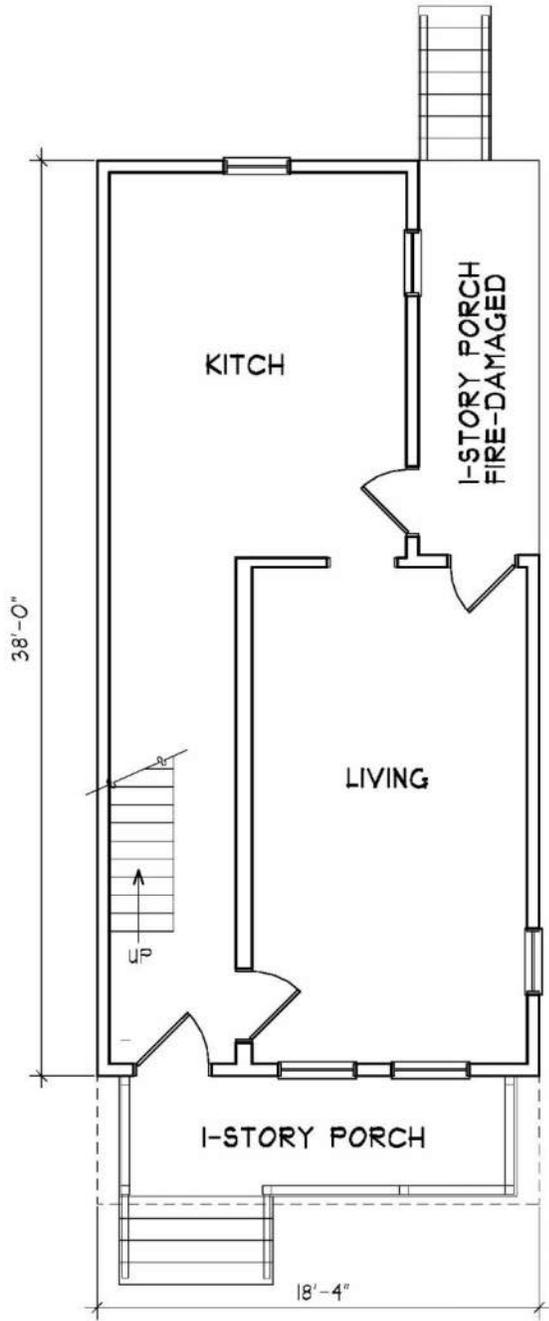
Right Side View

Interior – 2nd Floor
Typical Conditions

Rear View

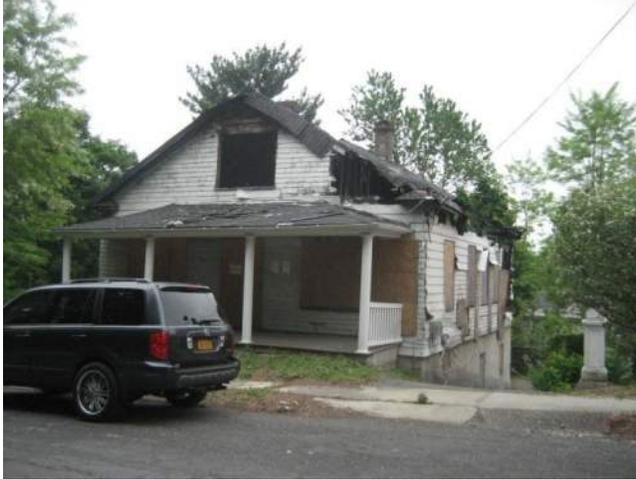
Photograph (1):

Front Elevation of the subject structure. Extensive fire damage is visible and the roof has partially collapsed.

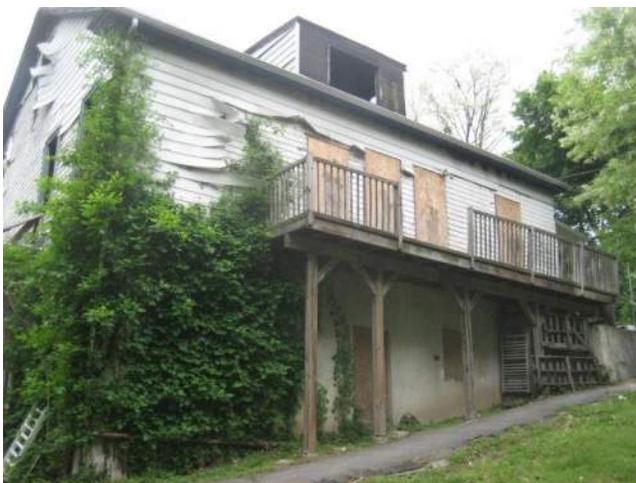
Photograph (3):

Left Elevation of the subject structure.

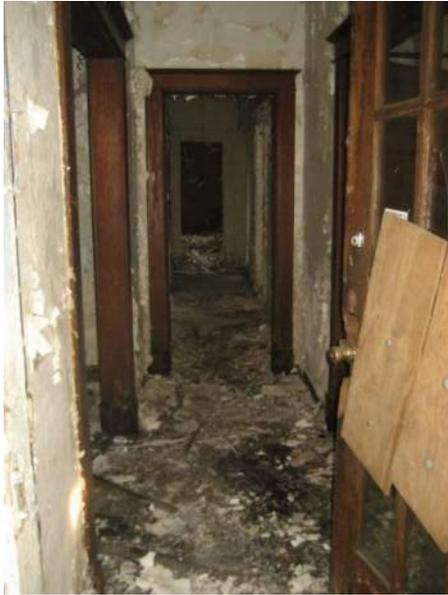
Photograph (4):

View of the first floor interior as viewed from the front entrance. The floor structure is severely water damaged and the load carrying capacity is greatly reduced.

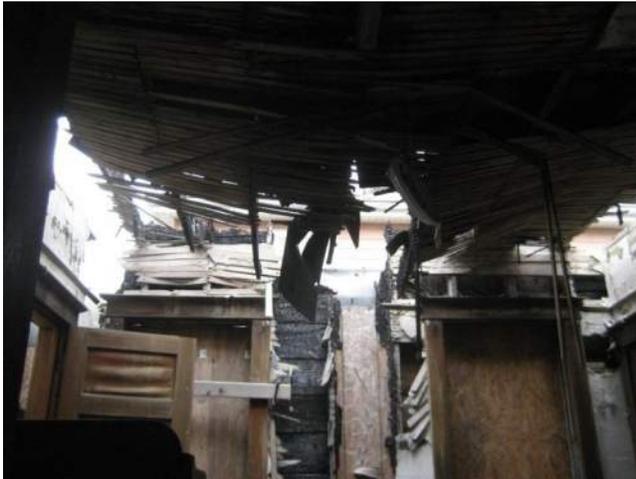
Photograph (5):

Representative view of the first floor interior near a collapsed area of roof.

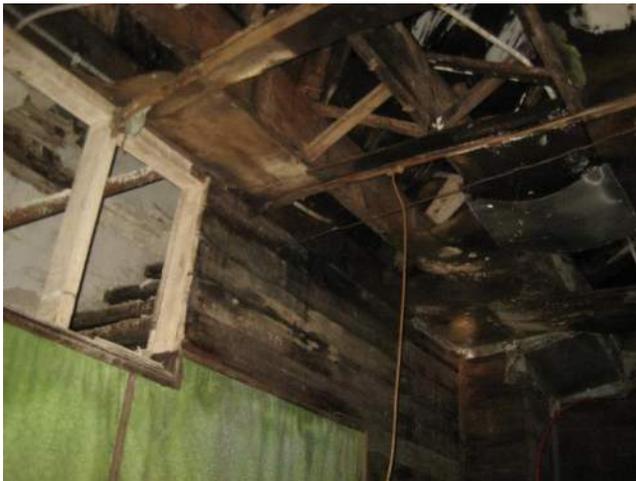
Photograph (6):

Representative view of the first floor framing as viewed from the basement. The framing is severely water damaged and in poor condition.

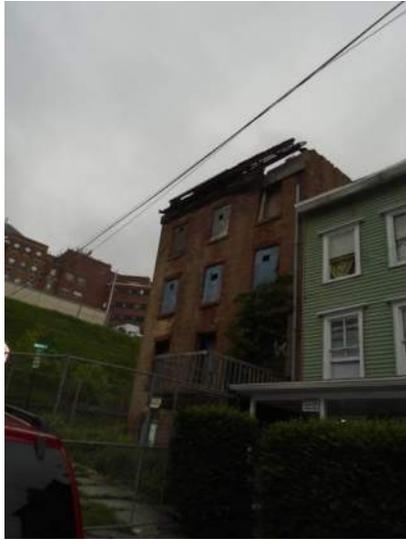
Photograph (1):

Front Elevation of the subject structure. The wood cornice structure at the roof level is unsecured and poses a fall hazard.

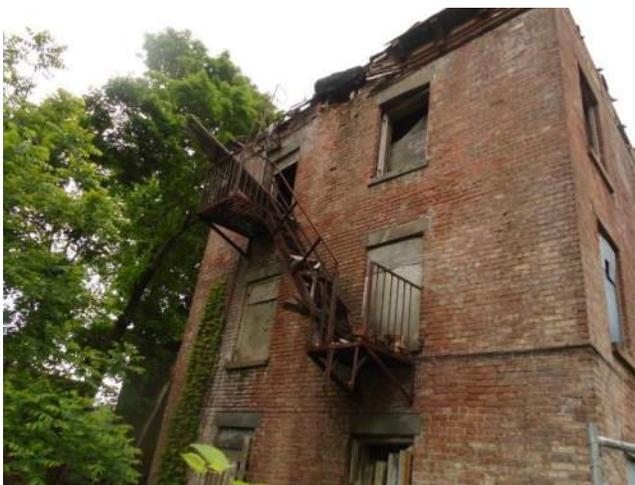
Photograph (3):

Rear Elevation of the subject structure. The wood cornice structure at the roof level is unsecured and there are several look bricks near the roof that pose a fall hazard. Several bricks/boards are visible on the deteriorated steel fire escape structure.

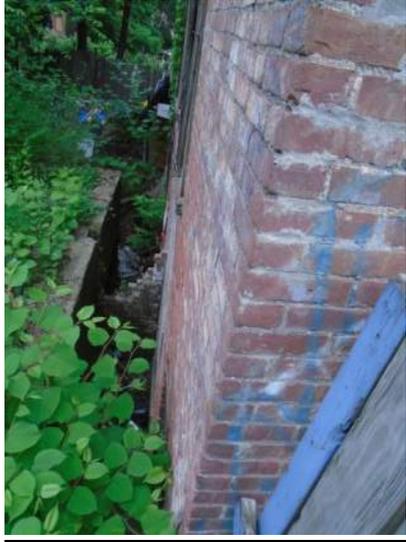
Photograph (4):

Rear Elevation of the subject structure. There is a recessed area of the overgrown backyard adjacent to the subject structure that may lead to a basement level. The condition of the retaining structure adjacent to this recessed area is unknown. This recessed area may pose a fall hazard to workers or first responders if not clearly marked or if overgrown in the future.

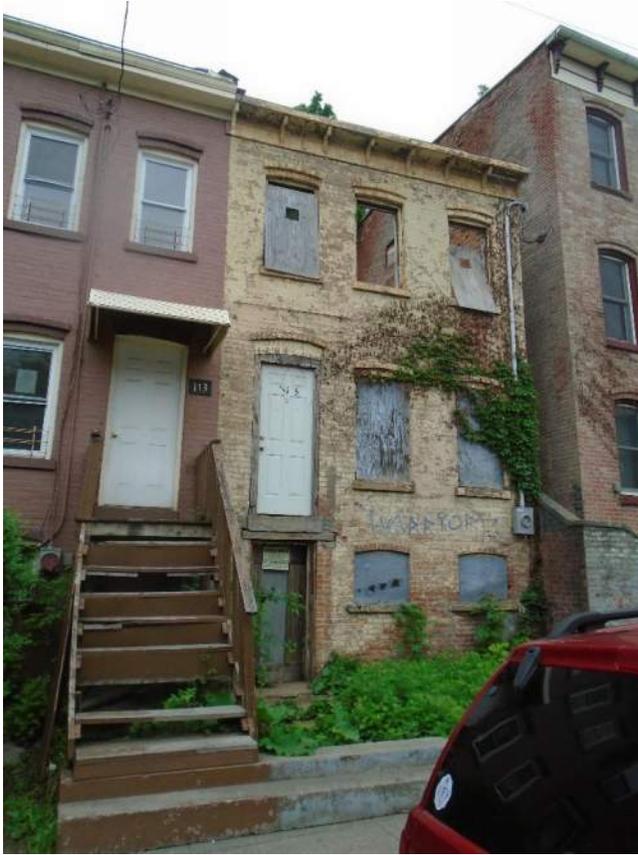
Photograph (1):

Front Elevation of the subject structure. The subject structure is a masonry “row building” this is in poor condition. The plywood window covering is loose from a third floor window, and the loose wood cornice structure, poses a fall hazard to the public.

The subject structure appears to share a masonry wall (“party wall”) with 113 Johnston Street. Chazen does not know if this adjacent structure is occupied, but the steps that lead to the front door are deteriorated and unsafe.

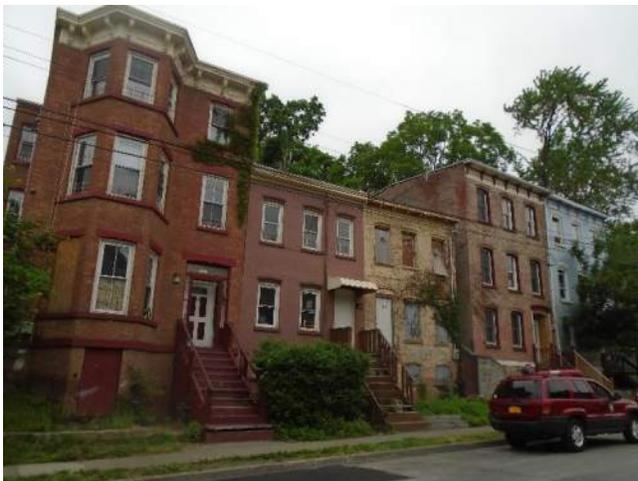
Photograph (2):

View of the Front Elevation of the subject structure and neighboring properties.
