Structural and Rehabilitation Assessment of
Twenty-One Vacant Structures
On Behalf of the
City of Newburgh
Orange County, New York

July 24, 2015

Chazen Project No. 31561.00

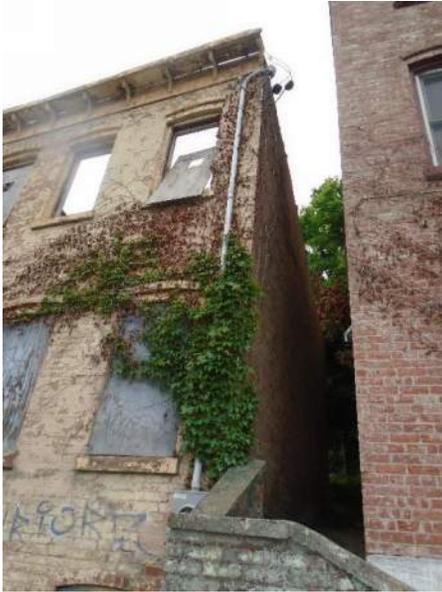
Photograph (3):

View of the Front-Right corner of the subject structure. The plywood window covering is loose from a third floor window, and the loose wood cornice structure, poses a fall hazard to the public.

The roof structure has collapsed and daylight is visible through the unsecured third floor window.

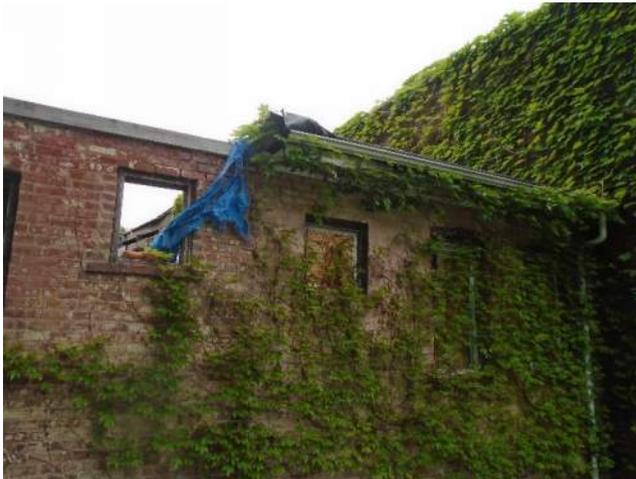
Photograph (4):

View of the Rear Elevation of the subject structure.

The roof structure has collapsed and daylight is visible through the unsecured third floor window. Climbing plants are growing over the subject structure.

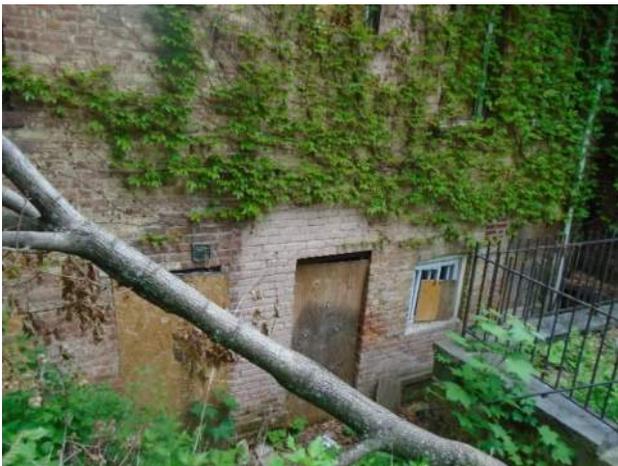
Photograph (5):

View of the Rear Elevation of the subject structure.

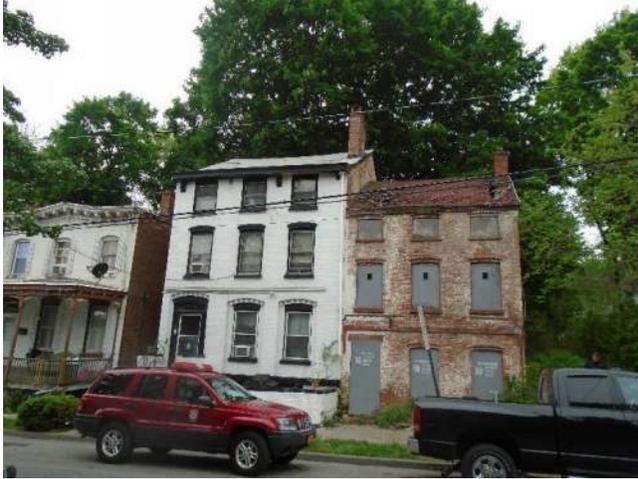
Photograph (1):

Front Elevation of the subject structure. The subject structure is a masonry “row building” that is in poor condition. Portions of the roof structure have collapsed.

The subject structure appears to share a masonry wall (“party wall”) with 137 Johnston Street.

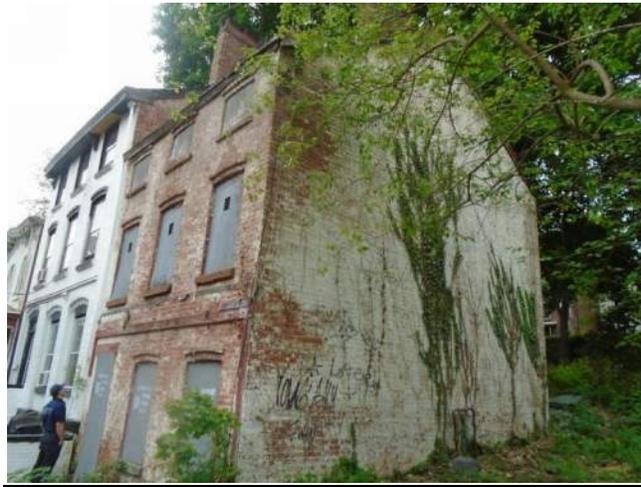
Photograph (2):

Right Elevation of the subject structure.

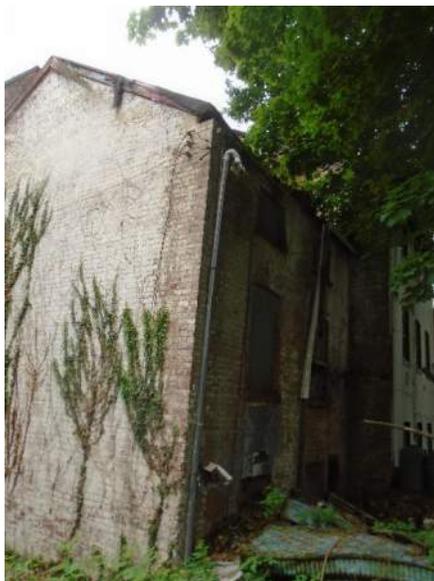
Photograph (3):

Rear Elevation of the subject structure. Portions of the wooden cornice structure are unsecured and falling off the structure.

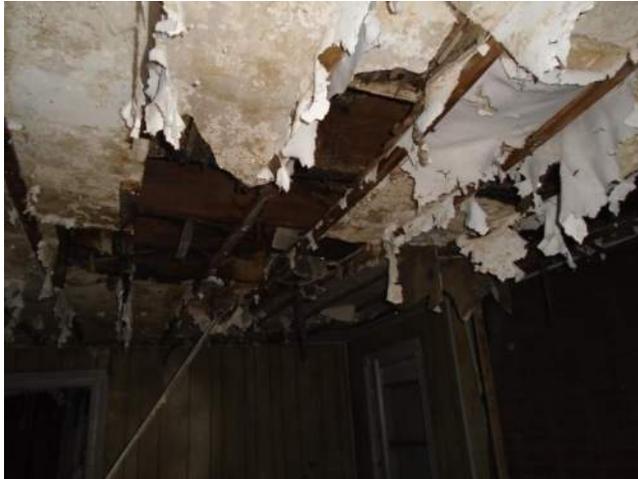
Photograph (4):

Representative interior view of the subject structure. The interior is severely water damaged.

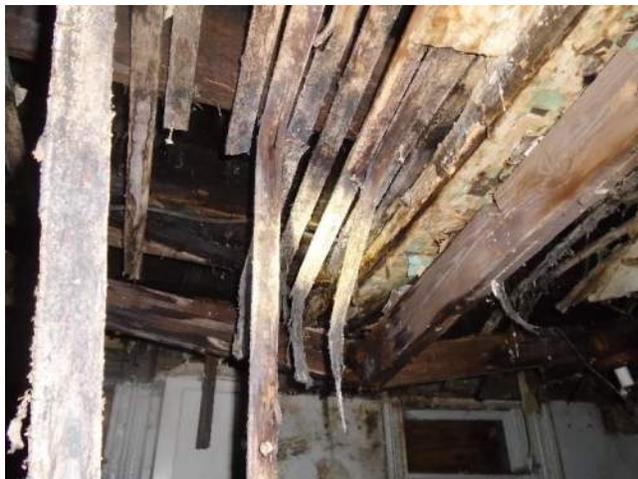
Photograph (6):

Representative interior view of the subject structure. The interior is severely water damaged. A portion of the second floor and roof structures have collapsed.

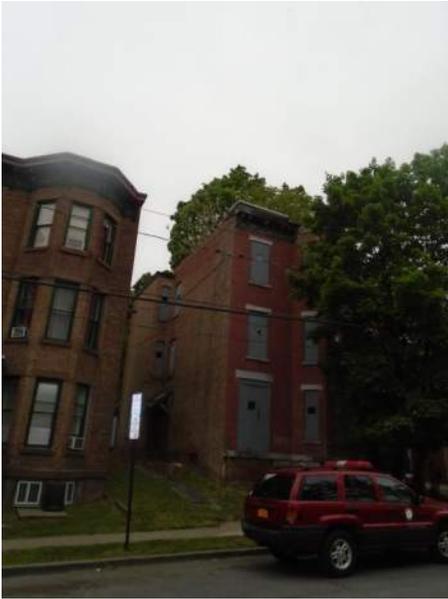
Photograph (1):

Front Elevation of the subject structure. The interior floor and roof structures have collapsed and the exterior masonry walls are no longer fully braced.

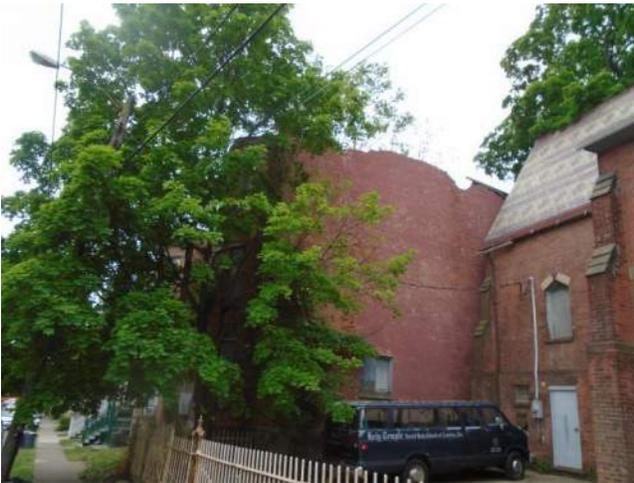
Photograph (2):

Right Elevation of the subject structure. The three story masonry wall is unbraced and poses a fall hazard to the adjacent property and the public.

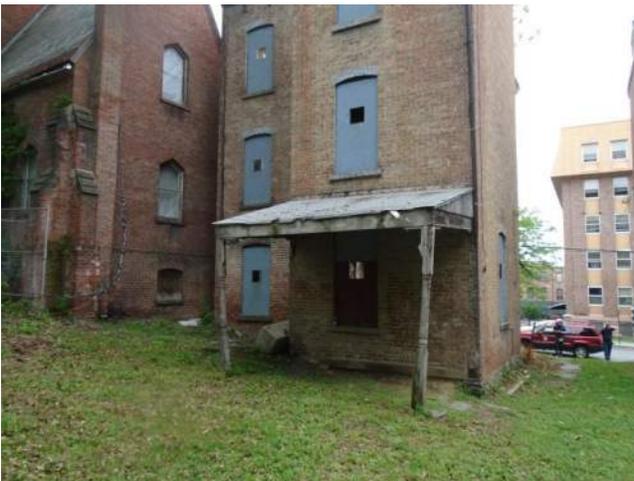
Photograph (3):

Rear Elevation of the subject structure. The wood lean-to structure is in poor condition.

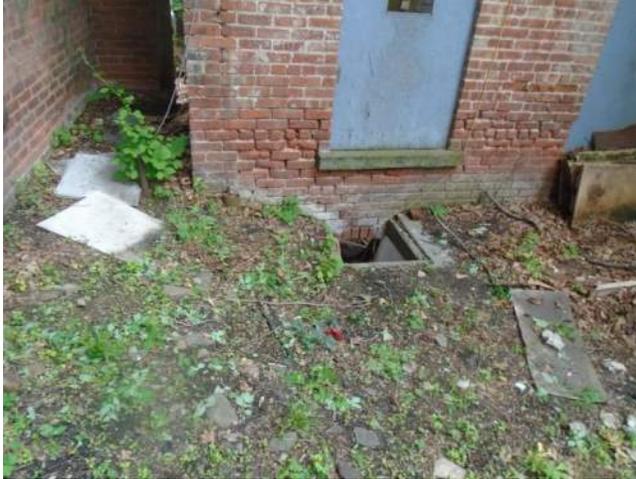
Photograph (4):

Exterior view at rear of subject structure.

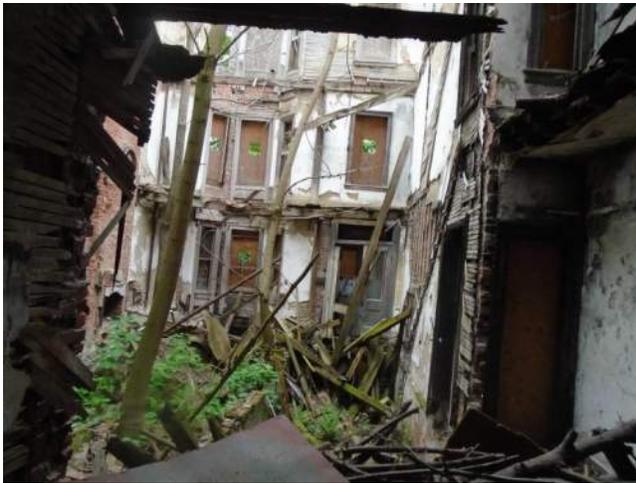
Photograph (5):

Interior view of the subject structure. The interior floor and roof structures have completely collapsed.

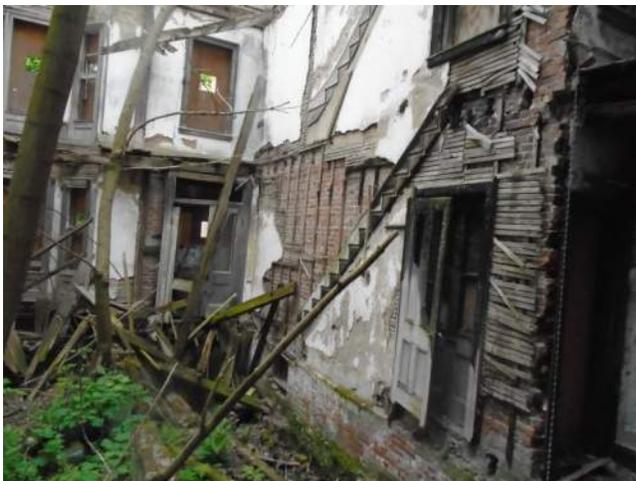
Photograph (6):

Interior view of the subject structure. The interior floor and roof structures have completely collapsed.

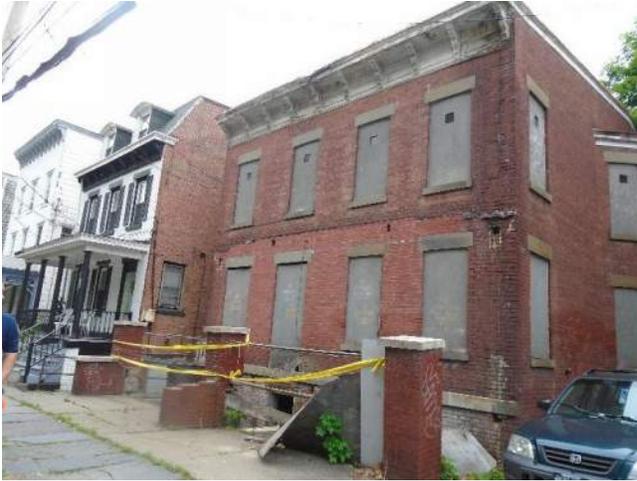
Photograph (1):

Front Elevation of the subject structure. The front façade appears to be in fair condition. There likely used to be a front porch structure that has since been removed.

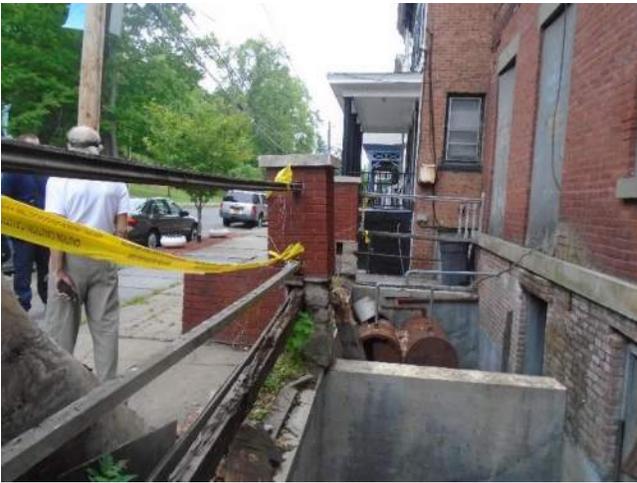
Photograph (2):

Front Elevation of the subject structure. The front façade appears to be in fair condition. There likely used to be a front porch structure that has since been removed. Wood guard rails and caution tape appear to warn pedestrians about the fall hazard but do not appear to provide the code required fall protection needed around these concrete vaults.

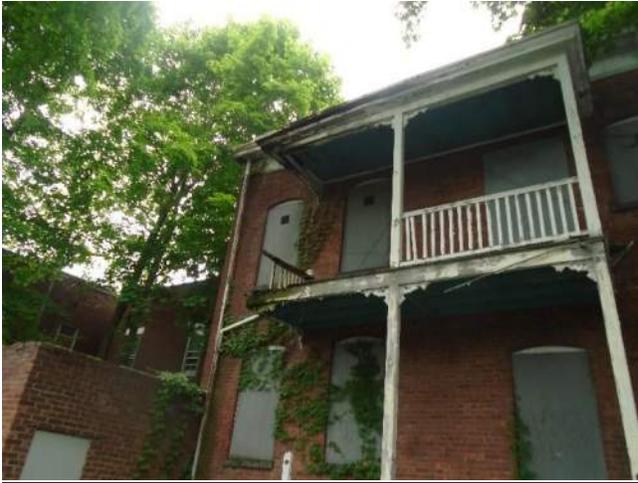
Photograph (4):

Rear Elevation of the subject structure. A post is missing from the rear porch structure. This porch structure is unstable and poses a fall hazard.

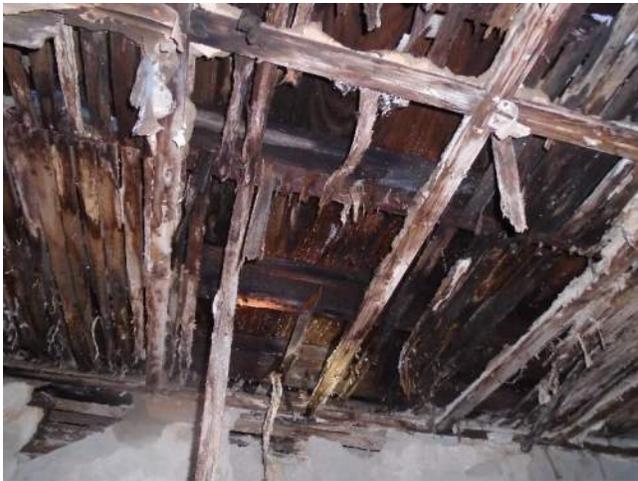
Photograph (5):

Representative interior view of the subject structure. Portions of the interior are severely water damaged.

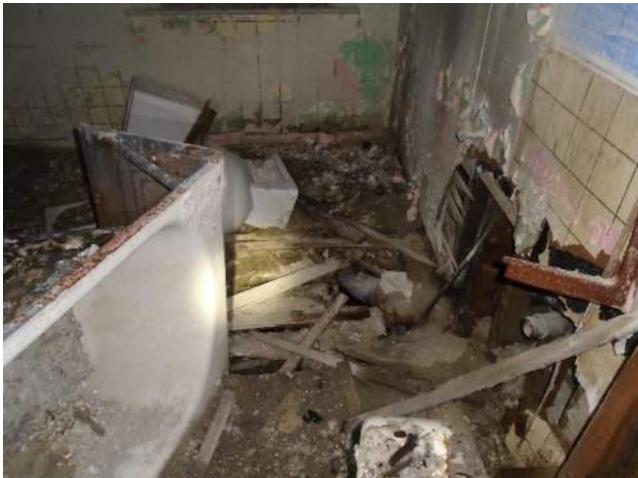
Photograph (6):

Representative interior view of the subject structure. Portions of the interior are severely water damaged.

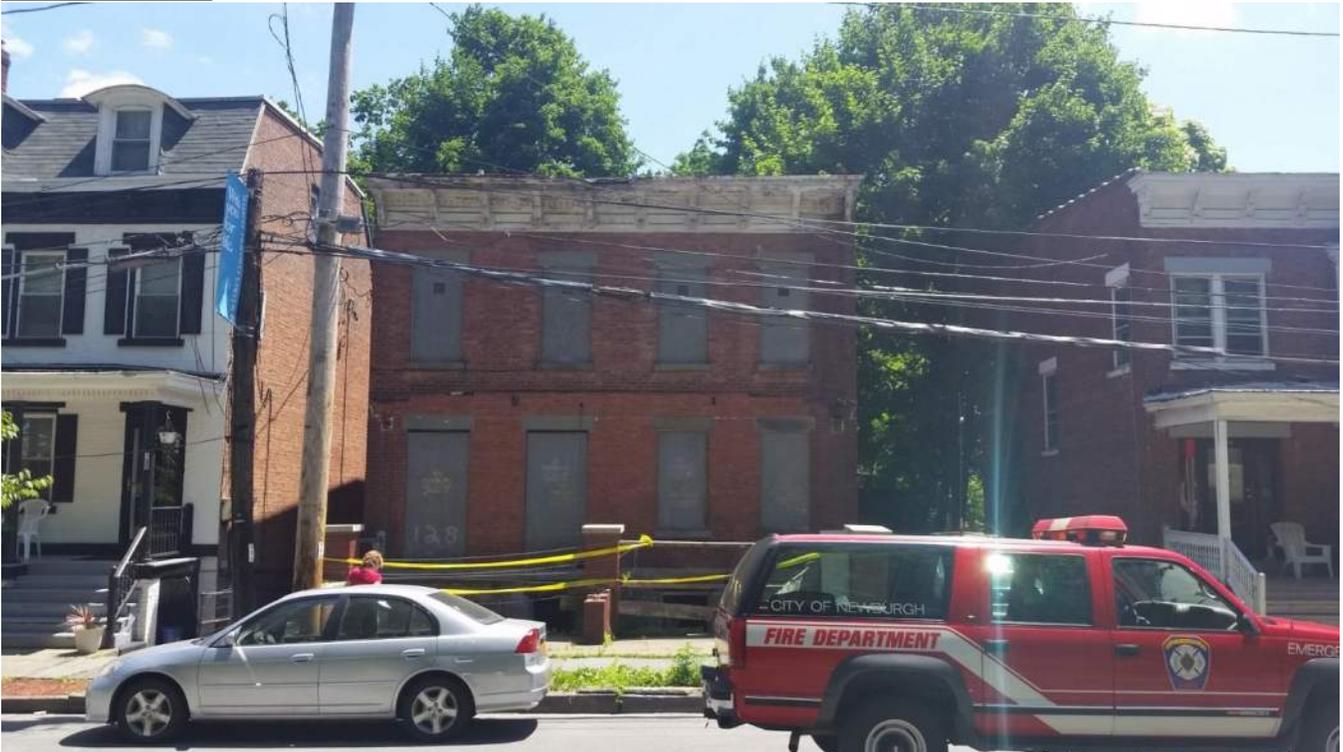
Front View

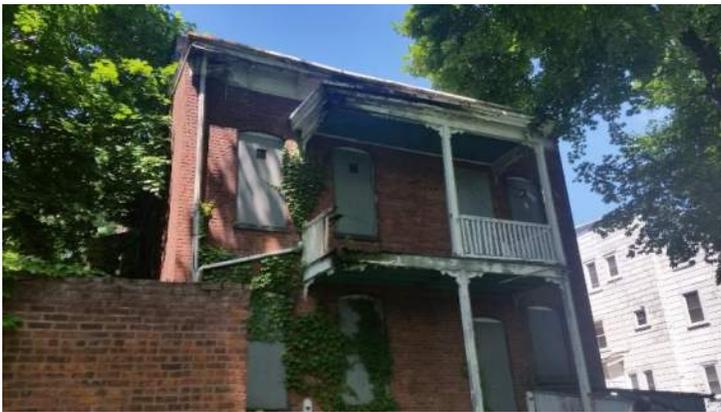
Right Side View

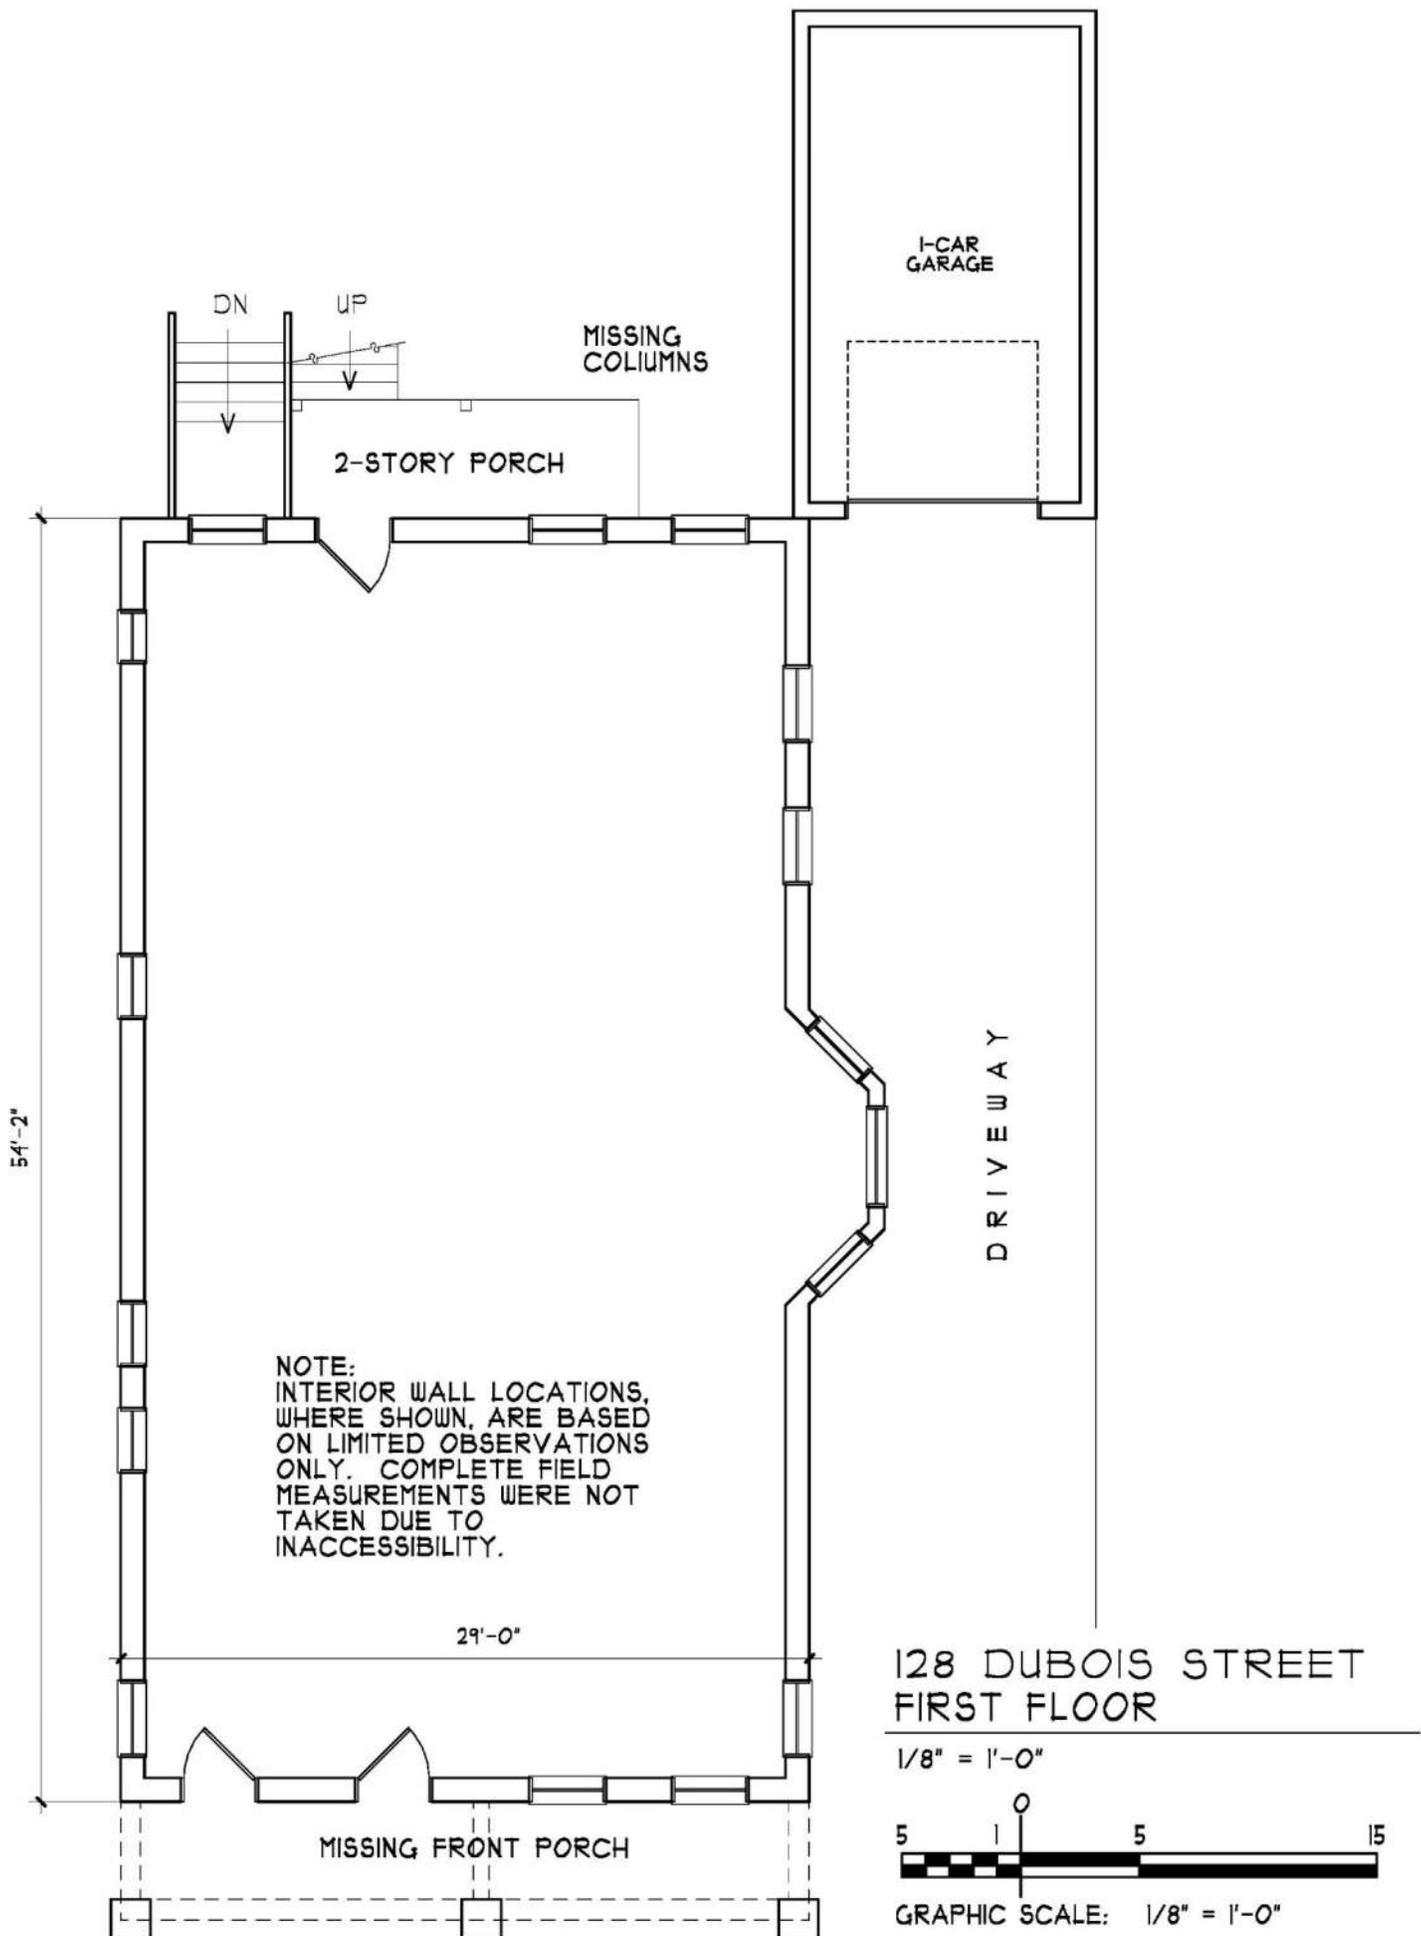
Basement: Access denied by NFD. Chazen info indicates moderate water damage throughout.
1st floor: Access denied by NFD. Chazen info indicates moderate water damage throughout.
2nd floor: Access denied by NFD. Chazen reports partial collapse, moderate water damage throughout.

Interior – 2nd Floor
Typical Conditions

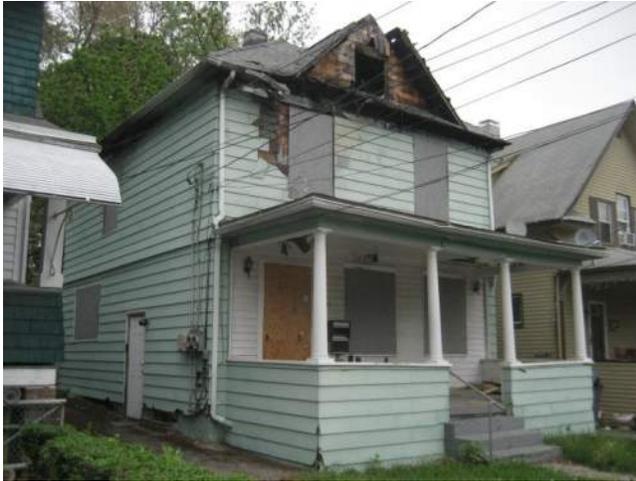
Photograph (1):

Front Elevation of the subject structure. Fire damage is visible in the attic dormer. Access to the interior is provided on the door from the driveway (left elevation).

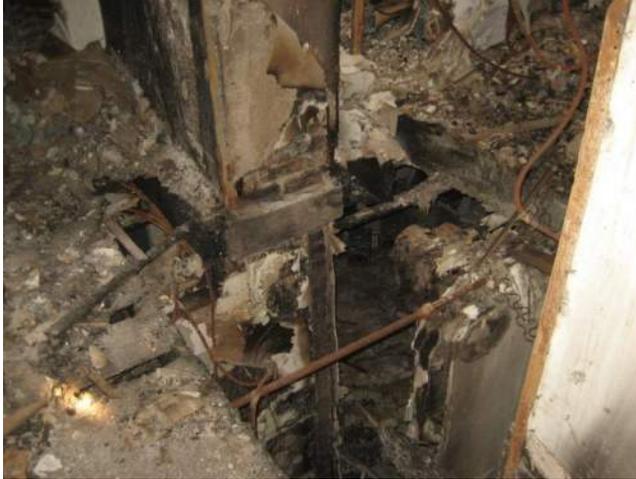
Photograph (4):

- Portions of the second and first floor structures have collapsed and pose a fall hazard to first responders. The wooden roof structure has partially collapsed and the interior is open to weather.

Interior of the subject structure as viewed from the second floor. Extensive fire damage is visible through the roof structure. Portions of the second floor structure have collapsed and pose a fall hazard to first responders.

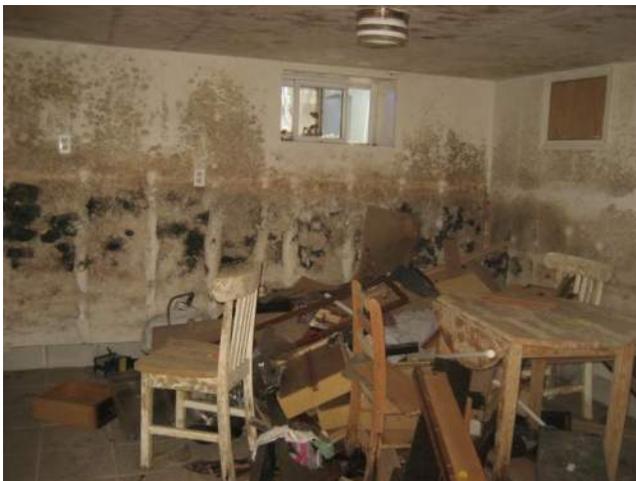
Photograph (6):

- There is a natural-gas-like odor in the front-right corner of the basement.
- The subject structure is in uninhabitable condition and appears to be vacant.

- There is significant water damage throughout the structure. Black-colored organic growth is visible on the finishes throughout the basement. There are piles of combustible debris throughout the subject structure.

Interior of the subject structure as viewed from the basement. The basement level is water damaged and black-colored organic growth is visible on finishes throughout basement. Piles of combustible debris are present. A natural-gas-like odor was smelled in basement near the right front corner.

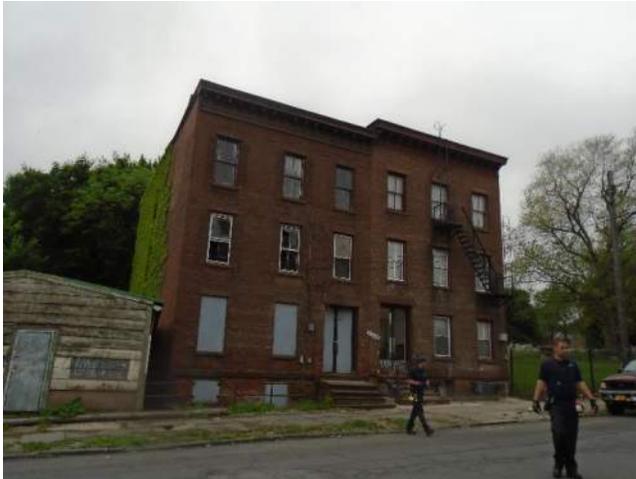
Photograph (1):

Front Elevation of the subject structure. The windows and doors are not boarded in secure in accordance with the municipal code.

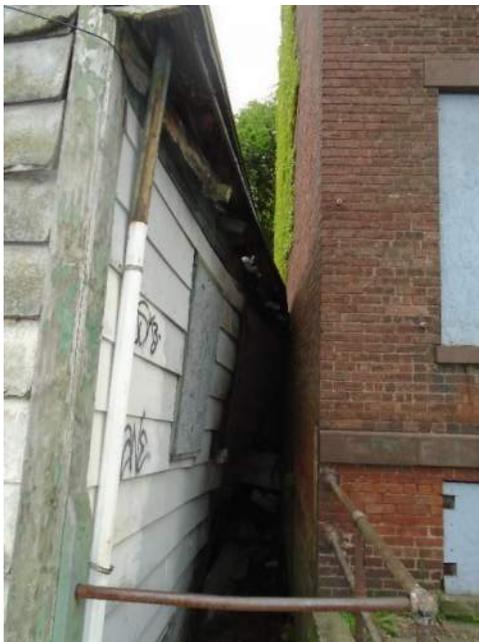
Photograph (2):

Left Elevation of the subject structure. There is an adjacent single-story vacant residential structure on the left elevation. The adjacent structure is collapsing and is contact with subject substructure.

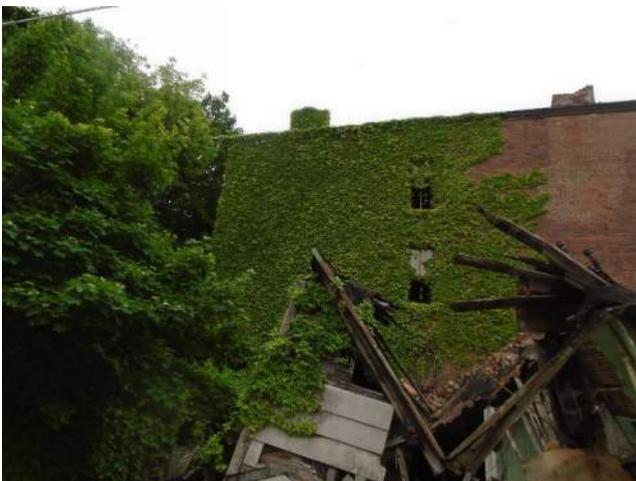
Photograph (3):

Left Elevation of the subject structure. There is an adjacent single-story vacant residential structure on the left elevation. The adjacent structure is collapsing and is contact with subject substructure. Climbing plants cover the majority of the rear of the subject structure.

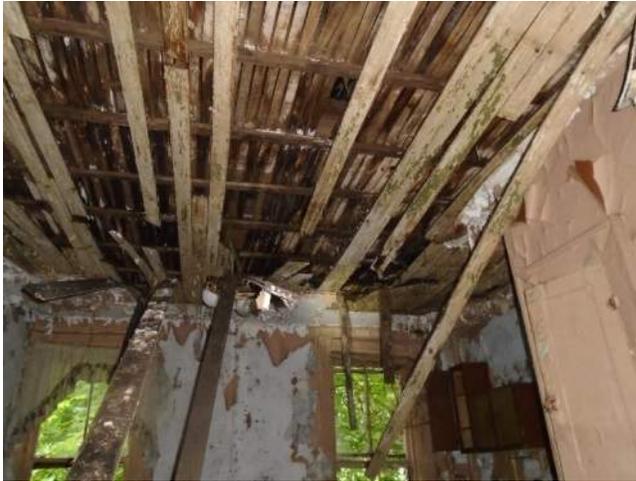
Photograph (4):

Representative interior view of the subject structure. The interior is generally water damaged and finishes are in fair to poor condition. Components of the ceiling are unsecured in several locations. There are dark colored organic growths throughout the structure.

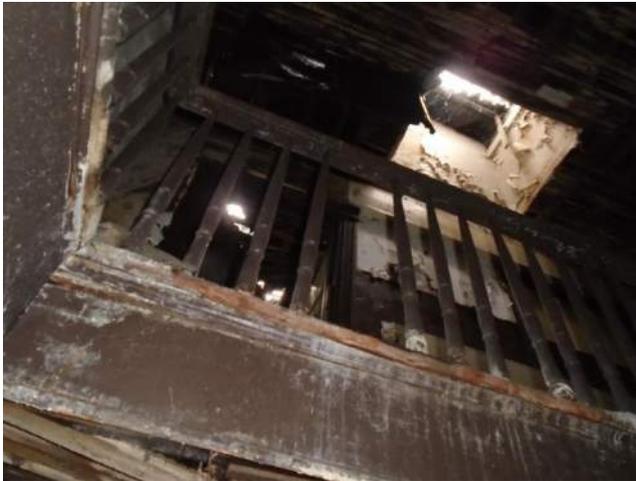
Photograph (5):

Representative interior view of the subject structure. Local portions of the roof structure have collapsed and weather is allowed and damage the interior structures.

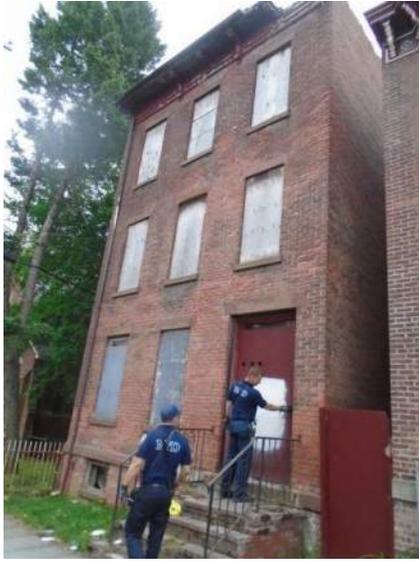
Photograph (1):

Front Elevation of the subject structure. The wooden cornice structure along the roofline is in poor condition and poses a fall hazard to pedestrians.

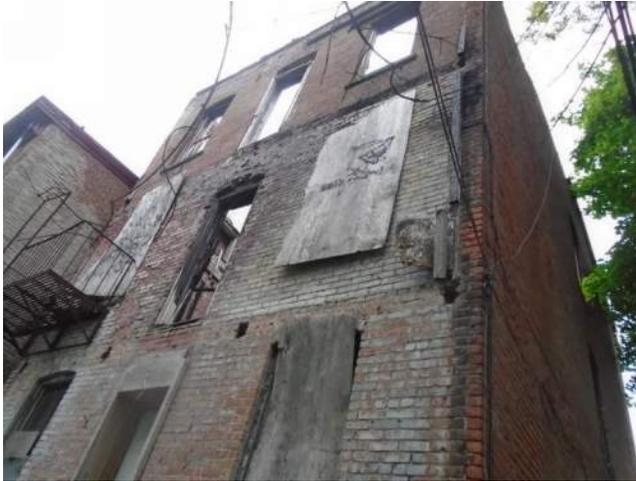
Photograph (3):

Rear Elevation of the subject structure.

The interior can be viewed through an open window on the upper levels. It appears the roof and interior floor structures have collapsed.
